Comparative study on field collected samples of aged silicon rubber composite coatings for high voltage insulators

Keywords: HV insulators, RTV SIR coatings, aging, characterization.

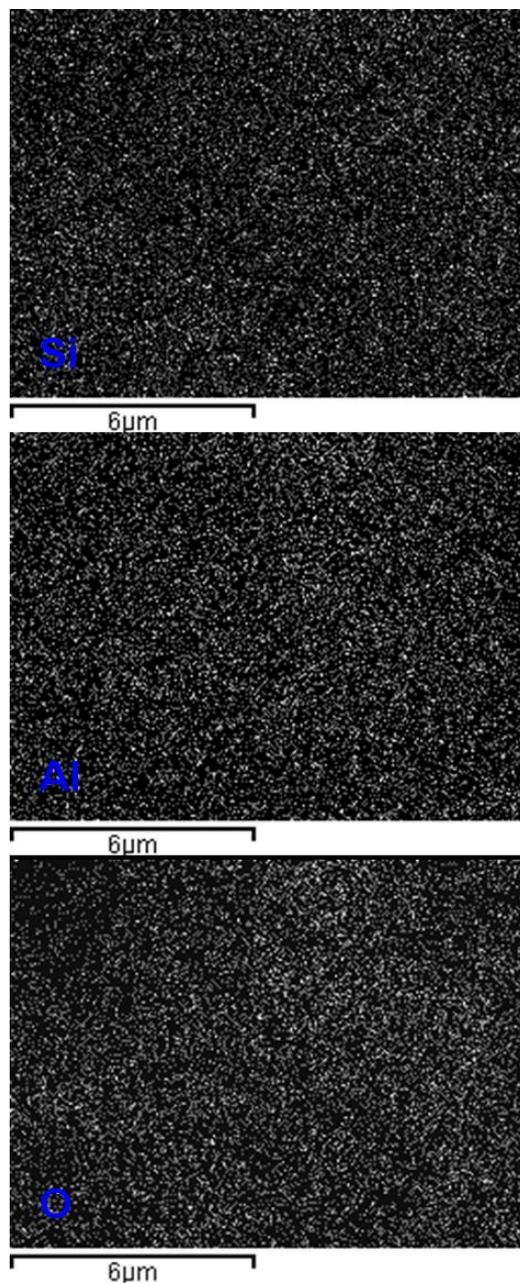
Figure 6. Elemental mapping of O, Si and Al in the analyzed sample.

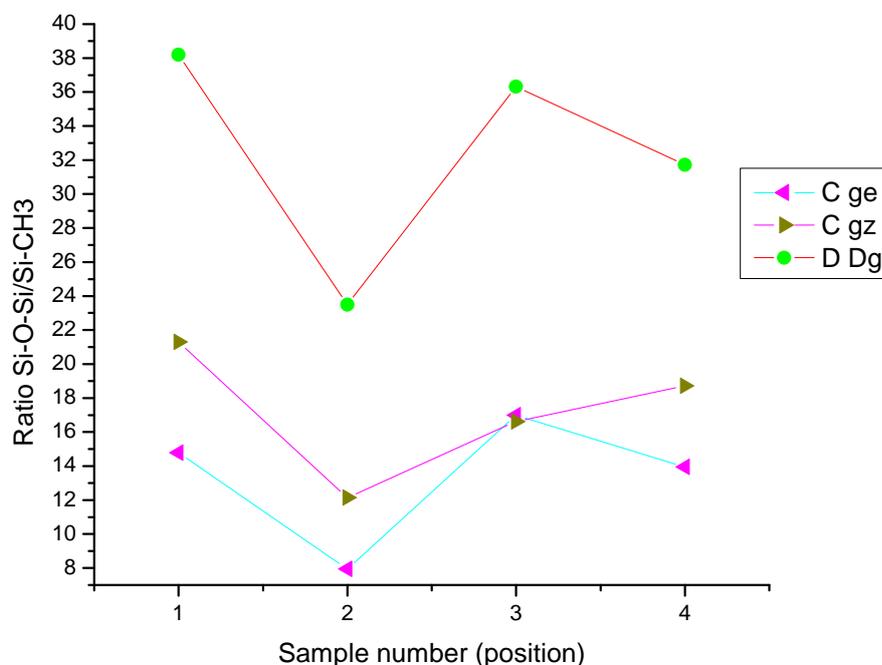
Figure 7. Graphical representations of the normalized areas ratios for Si-O-Si and Si-CH₃ bonds as a function of spatial position.

It is obvious from the above that the variation of normalized areas ratios values fulfils the initial assumptions regarding the normalized areas ratios for Si-O-Si and Si-CH₃ bonds as a measure of SIR HTV degradation and confirms the SEM observations. The oldest and most damaged sample Dg has the largest corresponding report values. Position 2 onto insulator has in all samples series the lowest local value while position 1 corresponds to highest degradation degree.
