CONDITION ASSESSMENT OF A FIELD-AGED 150 kV HTV SIR SUSPENSION INSULATOR FOLLOWING FLASHOVER

Abstract: Condition assessment results are presented for a field-aged 150 kV HTV SIR suspension insulator following its flashover due to bird nesting activity. The insulator, equipped with arcing horns, was operated for 10 years in a coastal transmission network under heavy environmental pollution. In order to evaluate flashover effects on insulator housing, several macroscopic and microscopic diagnostic techniques were employed including visual inspection, hydrophobicity classification, Fourier Transform Infrared spectroscopy (FTIR), Scanning Electron Microscopy (SEM) and Energy Dispersive X-Ray (EDX) analysis. Arcing affected the morphological structure and elemental composition, thus also hydrophobicity of the housing surface in proximity to arcing horns. The protection offered by the arcing horns together with the synthesis of the insulator housing material resulted in flashover deteriorating effects solely restricted to the upper surface layer of the housing. However, arcing caused excessive damages to the arcing horns. In addition to flashover, ageing and environmental pollution effe

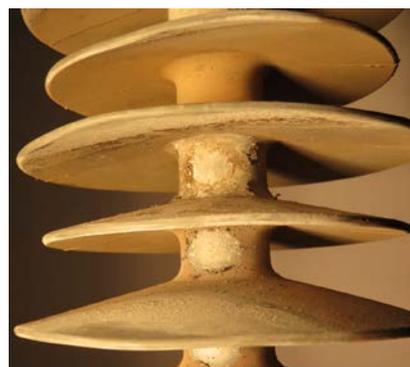
Visual inspection was performed according to STRI, EPRI and ESCOM guides [3 - 6]. Flashover effects were easily discernible on individual parts of the insulator along its polymeric housing and especially on the metal arcing horns. Focusing on flashover effects on insulator housing (Fig. 3), it was observed that the surface area at the side of arcing horns, especially close to the metal end fittings, was more severely affected than the remaining areas of the housing.

Figure 3: Flashover effects on insulator housing.

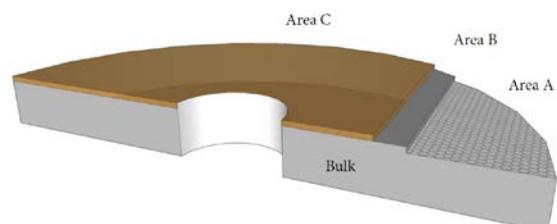
Three regions differing in surface state could be distinguished in the sheds and sheaths over the glass fiber core depending on the severity of flashover effects. According to Fig. 4, over surface area A, the most severely influenced by flashover, a thin white powder layer existed, as a result of burnt polymeric material. In addition, microscopic splits, irregularly spaced and variably intense, were detected, indicating increased surface roughness over area A. In area B neither damage nor pollution accumulation was optically detected. It is most likely that arcing removed the environmental pollution layer without causing surface damage. Area C was the part of insulator housing which remained unaffected by flashover. The surface environmental pollution accumulation was the dominant characteristic of this area.

Figure 4: Categories of insulator shed areas following flashover.

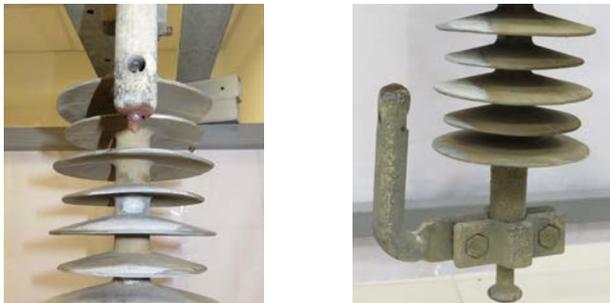
Concluding, visual inspection showed that flashover effects on the insulator's polymeric housing were not critical; no intense punctures and splits were detected, most probably due to the protection offered by the arcing horns. However, arcing caused excessive damage to the arcing horns. As evident in Fig. 5, their hemispherical ends were thermally damaged, actually deformed due to melting, and considerably oxidized.

Figure 5: Flashover effects on a 150 kV SIR insulator.

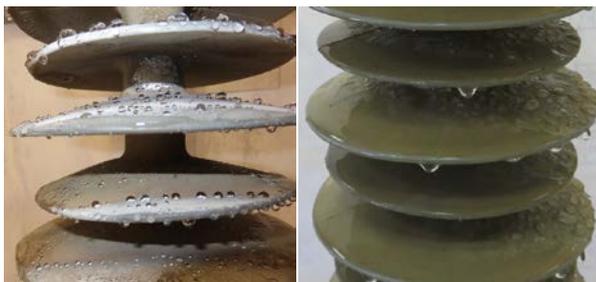
Spray test measurements showed that the flashed surface areas of the housing at the side of the arcing horns, areas A in subsection 3.1 (Fig. 4), were categorised into hydrophobicity class 1. On the contrary, along the non-flashed areas of the housing a thin surface water film was formed, corresponding to hydrophobicity classes of 4 and 5 (Fig. 6). These results indicate that the flashed areas of the housing were relatively free from environmental pollution accumulation.

Figure 6: Hydrophobicity classification; (left) flashed side and (right) non-flashed side of insulator housing.

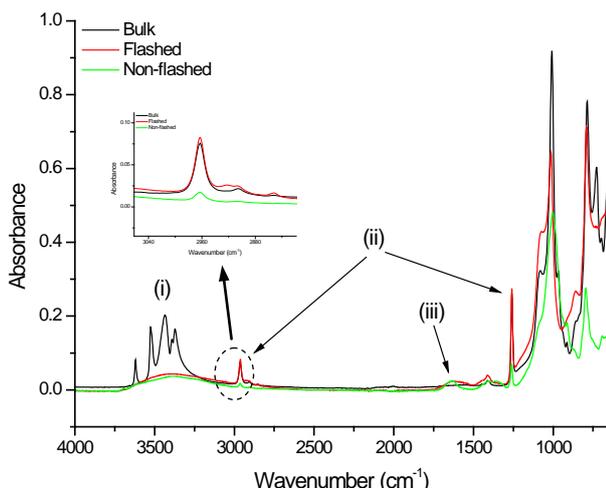
- The absorptions of trihydrate alumina are greatly reduced for both flashed and non-flashed samples as compared to the bulk material (Fig. 7, (i)).
- The absorbance of CH in CH₃ and SiCH₃ of the flashed sample is similar to that of the bulk material, whereas that of the non-flashed sample is greatly reduced (Fig. 7, (ii)). As these methyl groups are related to the hydrophobic properties of SIR, the non-flashed samples show reduced hydrophobic properties, most probably due to pollution deposition.
- An increase in OH bond of H₂O is evident for both flashed and non-flashed samples as compared to the bulk material (Fig. 7, (iii)); this indicates that the solid deposits in the flashed sample and the pollutants on the non-flashed sample were both water absorbing.

Figure 7: FTIR spectra of different surface areas of the insulator prior to cleaning.

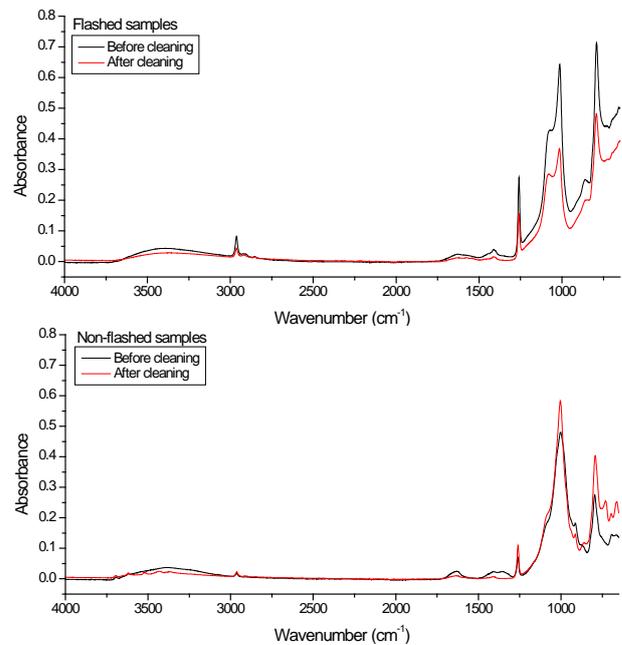
Fig. 8 demonstrates the effects of cleaning of the housing samples on the characteristic FTIR spectra. For the flashed sample a reduction in absorbance for all characteristic wavenumbers is evident after cleaning. For the non-flashed sample

Figure 8: FTIR spectra of flashed and non-flashed insulator samples before and after cleaning.

a relatively reduced absorbance is observed only for bands corresponding to OH vibration from alumina trihydrate and in H₂O, whereas for wavenumbers related to SIR polymer bonds the absorbance is enhanced.

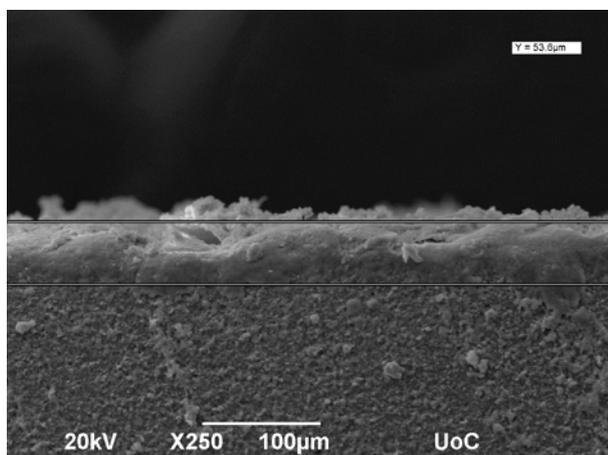
Scanning Electron Microscopy was implemented in order to investigate the morphological changes in the surface of the insulator housing after flashover. Prior to investigation the samples were sputtered with gold $\sim 10\text{ nm}$ in thickness. The examination of the flashed area showed that the damage due to arcing was limited to the upper surface layers, up to a depth of $50\text{ }\mu\text{m}$ (Fig. 9) significantly smaller than the thickness of the housing. On the non-flashed surface area environmental pollution deposition was detected (Fig. 10). Sodium chloride salt (NaCl) pollutants were transferred on the insulator housing by strong marine winds.

Figure 9: Cross section of a flashed surface area of the insulator housing (SEM image).

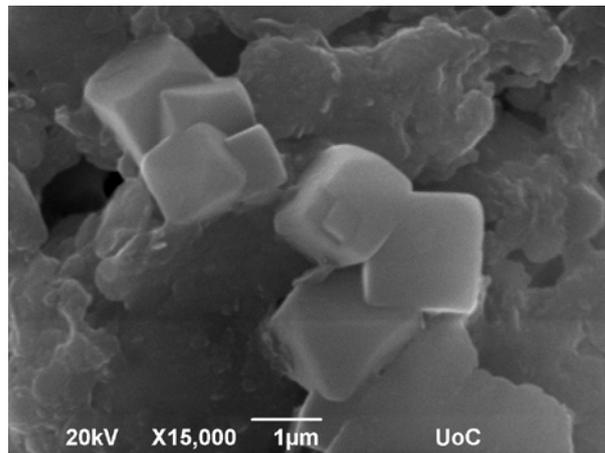
Figure 10: Salt (NaCl) deposited on non-flashed surface area of the insulator housing (SEM image).
