# Insulators' pollution problem: Experience from the coastal transmission system of Crete

N.C. Mavrikakis, and  
E. Koudoumas  
Electrical Engineering  
Department, Technological  
Educational Institute of Crete,  
Heraklion, Crete, Greece  
koudoumas@staff.teicrete.gr

K. Siderakis, D.  
Pylarinos, and  
E. Thalassinakis  
HEDNO S. A. Islands  
Network Operation  
Department, Heraklion,  
Crete, Greece  
k.siderakis@dieddie.gr

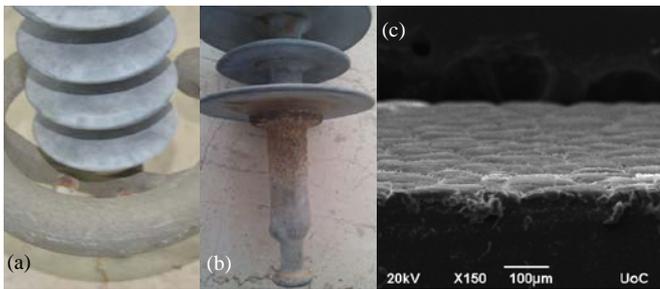
The surface morphological characterization was based on visual inspection according to field inspection guides and scanning electron microscopy (SEM) images. Discoloration was observed throughout the insulators' polymeric housing surface (Fig. 5(a)), and it was differed in intensity depending mainly on the polymeric material type [18]. Also, corrosion of metal end fittings was detected (Fig. 5(b)) to be more pronounced for the insulators installed close to coastlines, indicating that the sea-borne pollution contributes to the oxidation process of the insulators' metal parts. Finally, SEM images revealed surface cracking (Fig. 5(c)) on EPDM housings, which are the most discoloured ones [18].

Fig. 5. Discoloration of housing (a), corrosion of metal fittings (b) and cracking of housing surface (c)

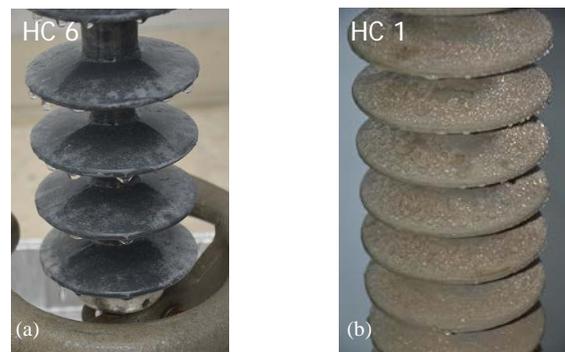
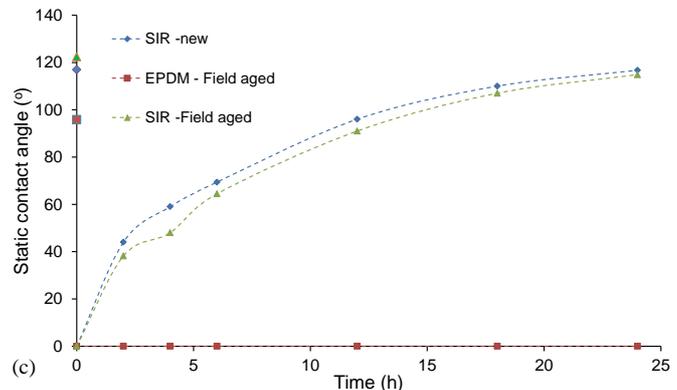
Wettability classification of the polymeric housings' surfaces of field-aged composite insulators was performed by using the spray method and the contact angle method according to IEC 62073 [19]. Also, the dynamics of the hydrophobicity, associated with hydrophobicity transfer mechanism, were evaluated [20]. Specifically, the field-aged EPDM housings were characterized as hydrophilic (Fig. 6(a)) before washing the accumulated surface natural pollution layer; however, after washing, they were hydrophobic [18]. On the other hand, the naturally polluted field-aged SIR housings were hydrophobic both before (Fig. 6(b)) and after washing. This behaviour, associated with the hydrophobicity transfer mechanism, was better demonstrated in [20]. It was found that the required hydrophobicity transfer time for the field-aged SIR housing was similar to the new (Fig. 6(c)). However, the surface hydrophobicity of the artificially polluted field-aged EPDM housing was lost (Fig. 6(c)).

Fig. 6. Hydrophilic behaviour of a field-aged EPDM insulator (a), hydrophobic behaviour of field-aged SIR insulator (b) and hydrophobicity transfer rate for field-aged and new housing materials (c). [20]

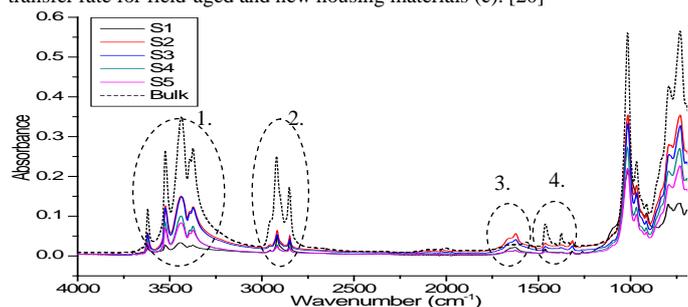
Surface material degradation of field-aged polymeric housings was investigated through EDX analysis and FTIR ATR spectroscopy. The results revealed oxidation of the rubber component of the housing material surface in a much higher degree for the case of EPDM than that of SIR [18]. FTIR results (Fig. 7) confirmed the structural changes of the polymeric housings' surfaces, showing scission of the rubber bonds (2 and 4 in Fig.7c), formation of hydroxyl groups (3 in Fig.7c) and dehydration of the filler (1 in Fig.7), which were more pronounced in the case of the EPDM insulators [18].

Fig. 7. FTIR spectra of surface (S1, S2, S3, S4, S5) and bulk material of the polymeric housing of field-aged EPDM insulators.

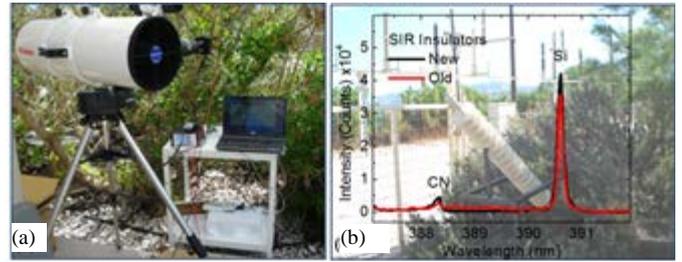
Fig. 9. (a) Remote LIBS collection-detection system at TALOS HV Test Station. (b) LIB spectra recorded upon irradiation of a new (stock) and a 21 yrs old (field-aged) insulator (Nd:YAG laser;  $\lambda=1064$  nm).

(reference) spectra corresponding to the new insulators ( $R_{OLD} = 0.07 \pm 0.01$  and  $R_{NEW} = 0.14 \pm 0.01$ ) (Fig. 9(b)). The reduced intensity ratio measured for the field-aged SIR insulators is attributed to the loss of CH<sub>3</sub> groups and/or Si atoms, caused by degradation of PDMS backbone, in agreement with ATR-FTIR measurements.
