Investigation of an Insulator Flashunder in an 150 kV OTL of the Power System of Crete

Abstract—Overhead Transmission Lines (OTLs) are used in Power Systems to carry High Voltage between substations, usually over long distances. Faults in OTLs are bound to happen and thus locating and coping with them is an important aspect of OTL's operation and maintenance. These faults may be of temporary or permanent nature, with certain types of faults progressing over time from the first category to the second. Local weather may also have a direct effect on the occurrence of faults resulting to puzzling events. A special category, often complex in nature, is insulator faults. Insulators are used in OTLs to support phase conductors while not allowing current to flow through the tower's body to the ground. Traditional ceramic insulators used materials such as porcelain and glass as insulation, but in the last decades composite insulators with two insulating parts (a glass core/rod and a rubber housing), have also known great use mainly due to their low weight and their capability to withstand pollution. However, they are subjected to certain faults unique to them, such as flashunders. Flashund

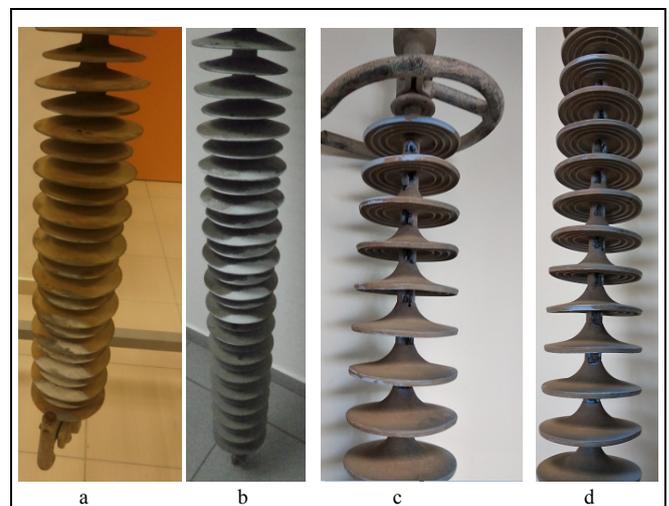
“Flashunder” has surfaced as a term commonly used to describe a bridging discharge conducted under the housing (in contrast to “flashover”) and along or within the core [12]. Internal tracking grows in or on the rod until a critical distance is bridged and a flashunder occurs [12]. A flashunder is visibly spotted when traces are ultimately created on the sheath, but the location and size of these traces makes them difficult to spot. On the contrary, a flashover is much more easily spotted as the power arc leaves easily visible traces on the sheds. Typical images from worldwide experience can be found in [3, 11-14] whereas additional images from flashed-over and flashed-under insulators removed from service from the Transmission System of Crete are shown in Figure 1. It should also be noted that, similar to the effect arcing has on recessing the pollution flashover process, a flashunder power arc may dry out the moisture from the rod/housing interface thus allowing the line to be re-energized, only to fail again after time or renewed wetting [12].

Fig. 1. Visible traces of flashover (discolored sheds) in a-b and flashunder (damaged sheath) in c-d. Photos a and b from past faults. Photos c and d from the insulator of the incident analyzed in this paper.

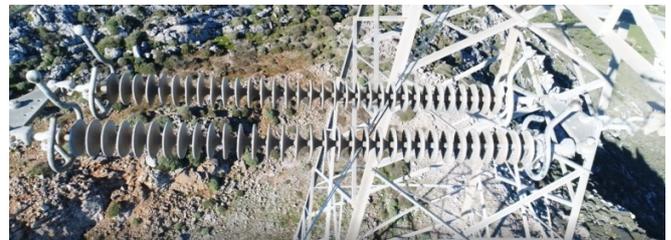
Fig. 4. The flashed under insulator with visible arc traces on rings. Sheath damage barely visible from this angle and distance.

The fault was found in one of the two insulators in a double tension string in Tower 29, located 13.73 km away from Sitia. Towers 28 and 29 are double circuit tension towers with the extra circuit endings being used in a way that facilitates a phase transposition (Figure 5), the only one in the Cretan Transmission System. These towers, known to suffer from strong winds and intense humidity in early mornings, are located at the top of a steep hill (Figures 6-7). For all these reasons, and even though the distances recorded from the fault

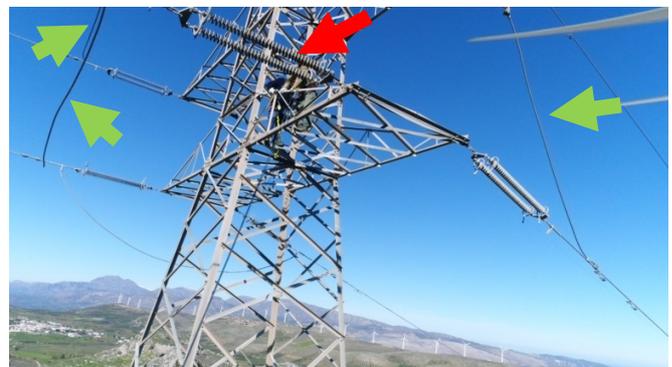
Fig. 5. A direct view of the flashed under insulator (red arrow). Some conductor parts used for phase transposition are also visible (green arrows).

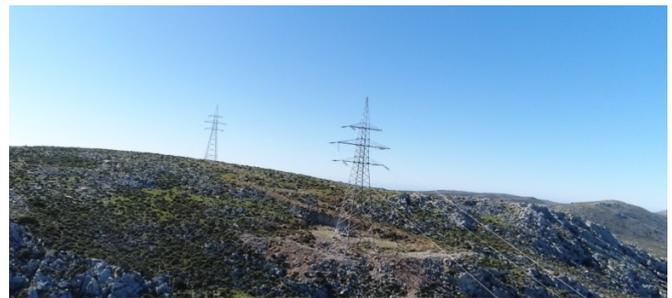
Fig. 6. A view of the location of Towers 28 and 29

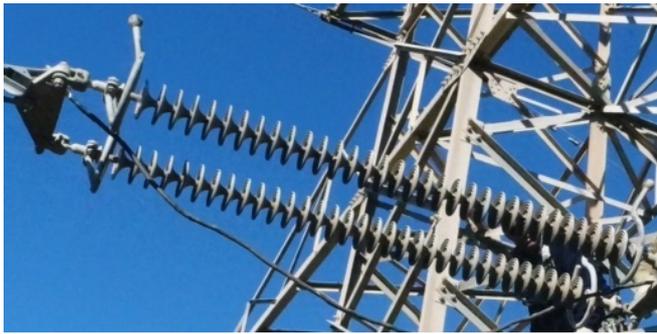
The insulator that suffered the fault was an even shed insulator, installed in a double tensions string. Thus, the sheds' shadows obscured the view of the sheath at most times and angles (Figures 8-10).

The location of the sheath damage was on the "outer" side of the insulator, i.e. facing away from the tower, making it difficult to spot from any angle accessible from the tower or the ground (Figures 8-10).

Fig. 8. Even from a small distance, the damage is not visible due to the sheds overshadowing the seath

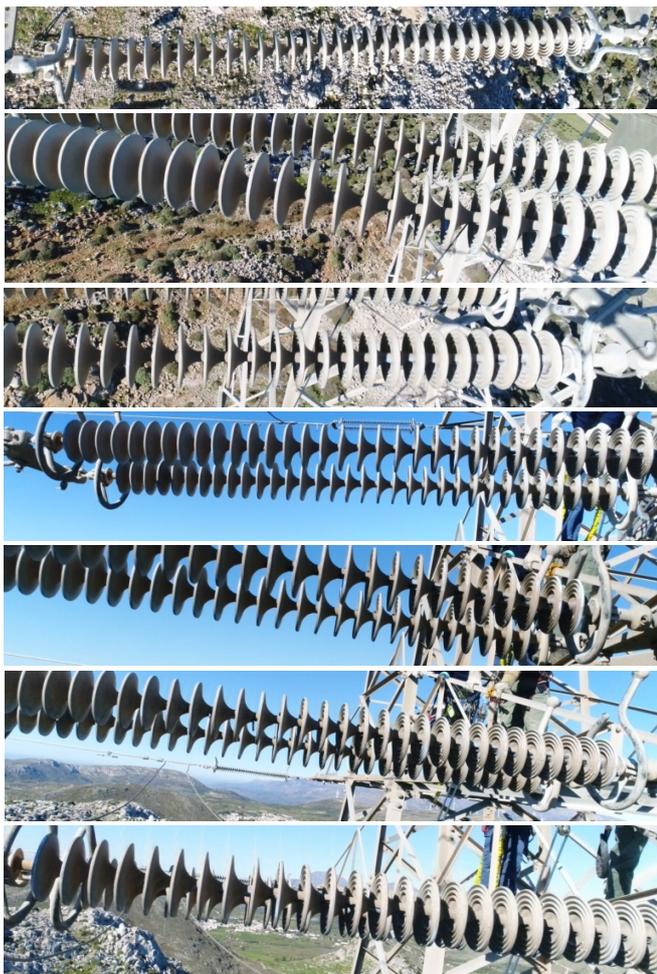
Fig. 10. Views of the flashed under insulator before its removal

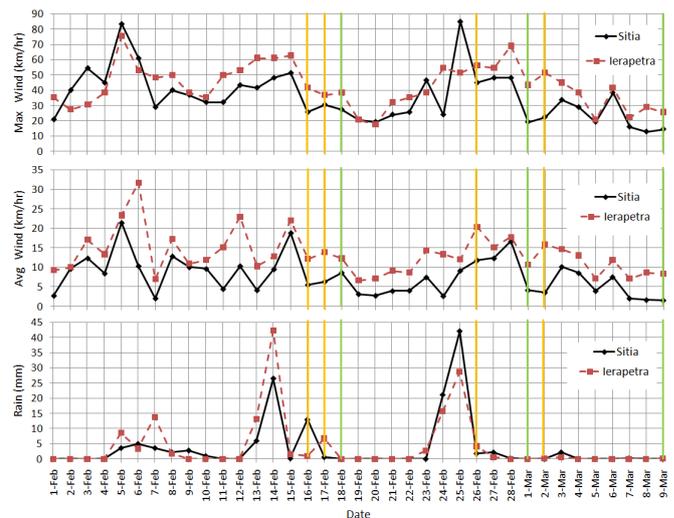
The micro-climate at Tower 29, and especially values with a strong locality factor such as relative humidity (RH), can not accurately be described by the recordings in either Ierapetra or Sitia (thus the RH measurements are not shown in Figure 11). It was known that Tower 29, being located at a top of a steep hill, was subjected to intense humidity (fog/mist) in early mornings. The same could be hypothesized for late afternoons. However, even when a possible flashunder was brought to the table as a strong possibility, the time of faults would not back a correlation with high RH values either. The first fault was recorded at midday of Feb 16 (at 14:20), the line was re-energized on Feb 18 and the next fault was recorded on Feb 26 at 08:49. Thus, no safe correlation with morning and afternoon fog/humidity could be established.

Fig. 11. Weather data from weather stations in the National Observatory of Athens network located in Sitia and Ierapetra. Yellow vertical lines indicate the occurrence of fault(s). Green lines indicate the re-energization of the line.
