FIELD MEASUREMENTS OF LEAKAGE CURRENT ON PORCELAIN AND RTV SILICONE RUBBER COATED INSULATORS

Abstract

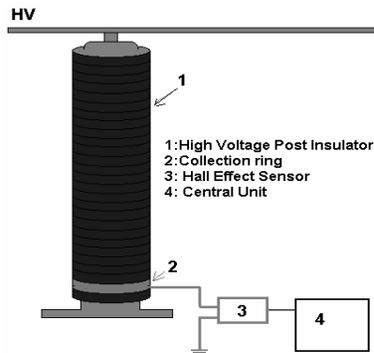
The measurement of leakage current is possible by inserting in the LC path a collection ring and a hall sensor. Then the measurement is transmitted to the central unit where it is processed and stored. The sampling frequency of each channel is 2 kHz and all the channels are simultaneously sampled. (Figure 1)

Figure 1: Measurements setup

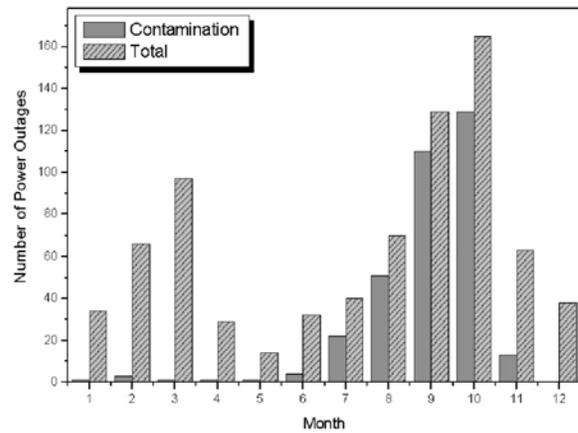
The pollution problem in the case of ceramic insulators is observed at the end of the summer until the onset of the rain period (August to October and sometimes November). During this period precipitation is absent (cleaning factor) and due to the sea influence contamination is accumulated on the surface of insulators. Thus at the end of the summer, after 3 to 4 months of accumulation the necessary wetting mechanism comes to surface. Atmosphere humidity during the night (condensation) transforms the contaminants layer to a conductive film and surface activity takes place. In figure 2 the distribution by month of the pollution related faults, observed in Transmission Lines (ceramic insulators) is shown.

Figure 2: Monthly distribution of power outages (contamination and total) from 1969 to 2004

The intensity of the problem during the above mentioned period may be verified by the rapid increase of the observed faults.

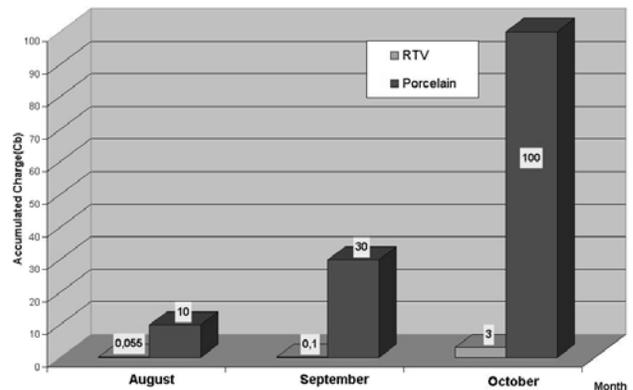
In figure 3 the accumulated charge on two identical insulators, with and without a coating is shown, for three months of the pollution period (August, September and October). These insulators are installed in the same place, as it can be seen in figure 4 and when the measurements took place the coating was 1,5 years old. It must also be mentioned that the porcelain insulators are washed twice during this period.

Figure 3: Accumulated charge on two identical insulators, with and without a RTV coating for the period from August to October (average values)

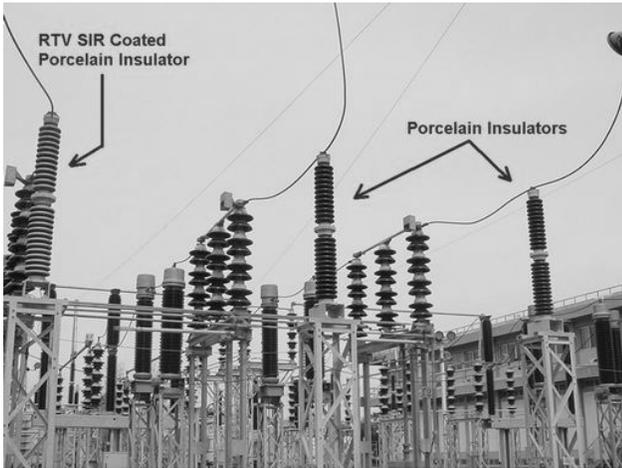
Figure 4: Monitored 150kV insulators at site 1. One of them is RTV coated and the other two uncoated.

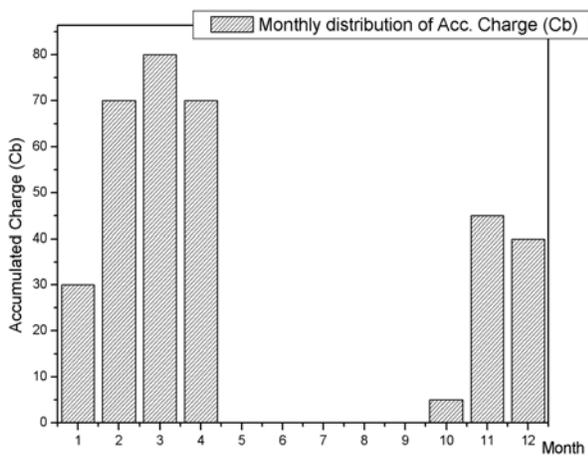
Figure 5: Accumulated charge on RTV SIR coatings (average value) by month for one year monitoring at site 2.

Thus as long as the coatings maintain a hydrophobic surface, the possibility of a flashover is minimized. However the continuous monitoring of LC around the year indicated that in the case of coatings intense activity is observed, but during a different time period. In figure 6 a monthly distribution of the average accumulated positive charge, from measurements at site 2 is shown.

Combining figure 5 with figure 6, where the monthly distribution of average precipitation at Heraklion is shown, it can be seen that the period of activity in the case of coatings, comes along with precipitation. This may be verified also in figure 7, where the simultaneous

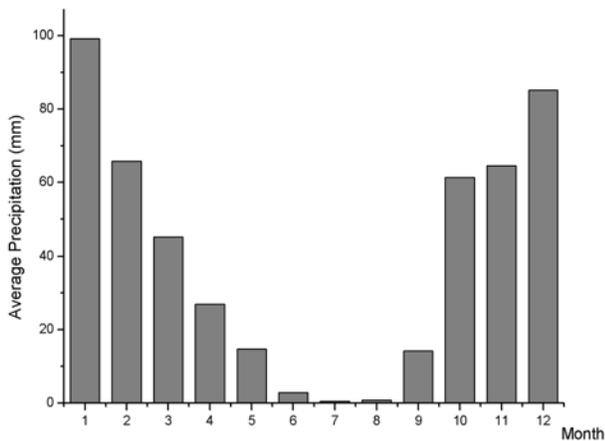
Figure 6: Average monthly precipitation at Heraklion (sites 1 and 2).

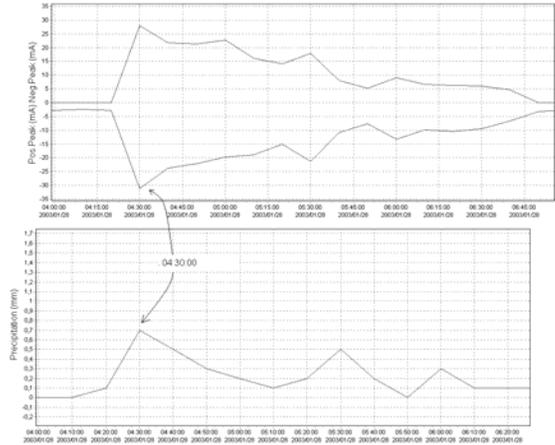
Figure 7: Peak positive and negative values of LC during light rain on an RTV SIR coated insulator at site 2.

measurements of the peak positive and negative value of LC (in the case of a coated insulator), and precipitation are shown.

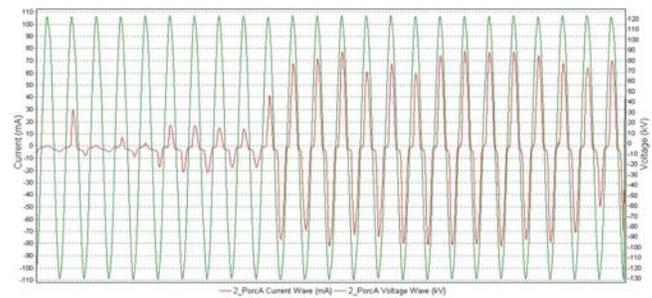
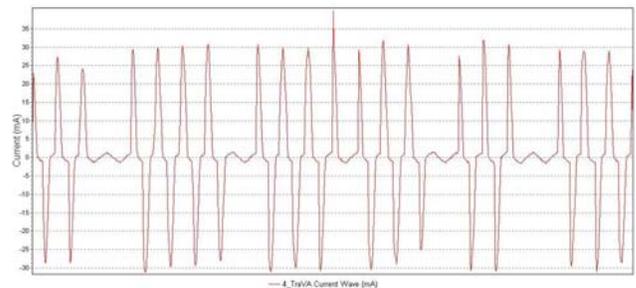
On the other hand in the case of hydrophobicity loss the waveform of leakage current obtains higher values, especially in the case of a dry band discharge. Figure 8a is a typical measurement of LC on a porcelain insulator, in the case of a dry band discharge. Figure 8b is also a measurement of LC (dry band discharge) but in the case of an RTV coated insulator.

Figure 8: (a) Leakage current and voltage waveform on a 150kV porcelain post insulator at site 1, (b) Leakage current waveform on a 150kV porcelain post insulator at site 2

The leakage current waveforms in both cases seem to be similar. The frequency spectrum (figures 9a and 9b respectively) indicates a large 50Hz frequency component and also a large component at 150Hz in both cases. This similarity occurs since the behaviour of the RTV coating in the case of a hydrophobicity loss is similar to porcelain. Therefore in this case an appropriate leakage path is necessary to ensure the suppression of surface activity.

It is also important to notice, especially in the case of figure 8a where the corresponding voltage is also shown, the dominant resistive component of LC, indicating the existence of a resistive conductive layer and therefore the dissipation of energy on the coating's surface. Additionally the presence of a non linearity in the leakage current (in both cases) also reveals the presence of an arc resistance in series. This non linearity can be seen in the frequency spectrum (150Hz component) and also in a Voltage versus Current diagram (figure 10).

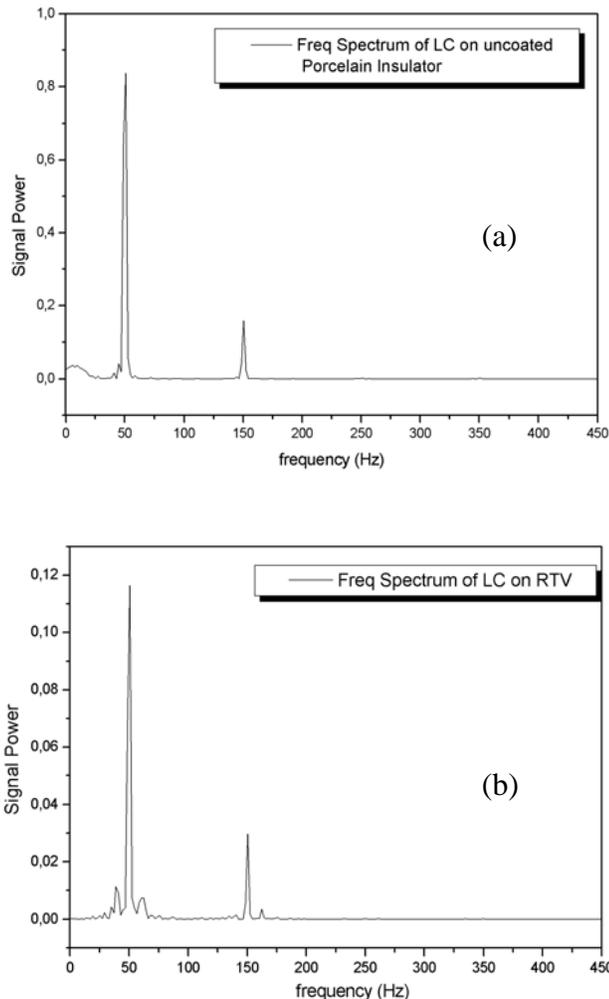
Figure 9: (a) Frequency spectrum of the Leakage current waveform on a 150kV porcelain post insulator at site 1, shown in fig 8a. (b) Frequency spectrum of the leakage current waveform on a 150kV porcelain post insulator at site 2, shown in fig 8b

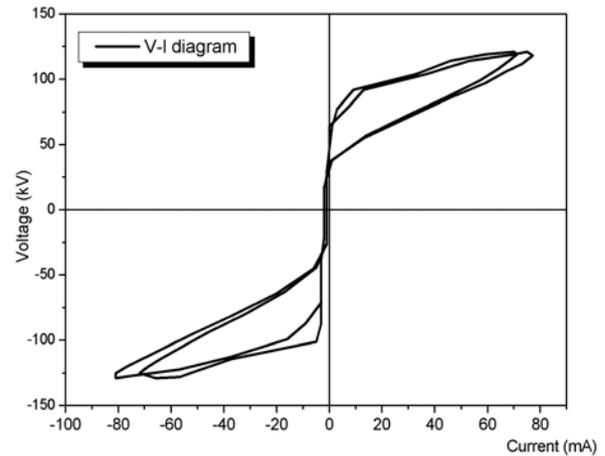
Figure 10: Voltage Current diagram for the waveforms of LC and Voltage in figure 8a.

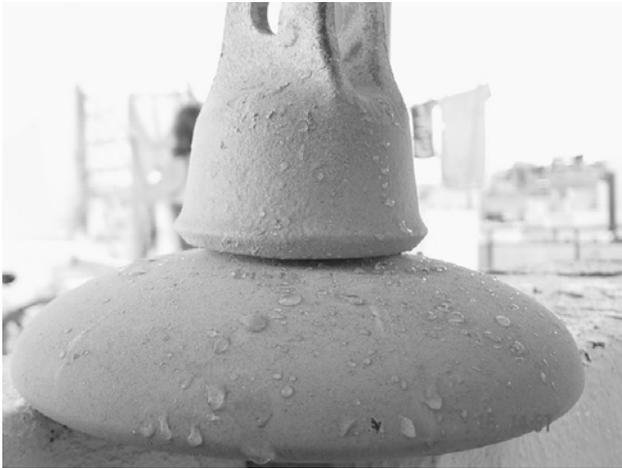
Figure 11: Hydrophobicity measurement on an RTV SIR coated porcelain insulator with a contamination layer.

In figure 12 the contaminants layer in the case of the insulator shown in figure 11 has been removed and as it can be seen the behaviour is hydrophilic. Of course it must be mentioned that in this case the energy supplied by the hand friction when removing the pollution also contributes to the loss of hydrophobicity by changing the orientation of the side methyl groups in the Silicone Rubber molecule (second hydrophobicity mechanism). However the reorientation will take place very fast after the excitation mechanism cease.

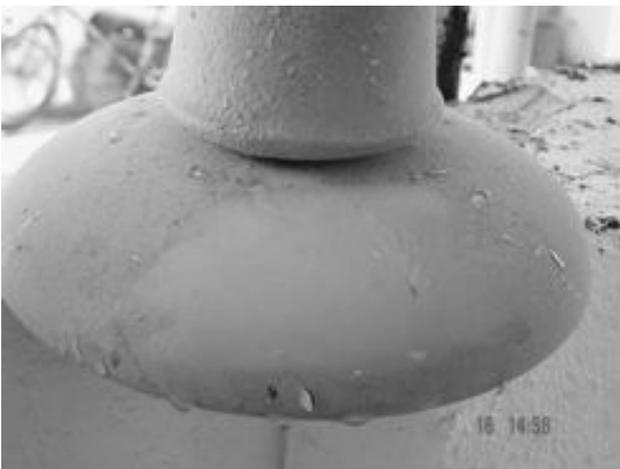
Figure 12: Hydrophobicity measurement on an RTV SIR coated porcelain insulator. The contamination layer has been removed and a hydrophilic behaviour is observed.
