Polymer Insulators and Coatings in the Cretan Power System. The Transmission Line Case

Abstract—The reliability of Transmission Systems largely depends on the performance of the HV insulators used in Substations and Transmission Lines, and thus, insulation coordination and research is a rather important issue for power utilities. This paper's focus is on the Transmission Line case of the power network of Crete. The Cretan network faces severe pollution problems and the Greek utility has employed several remedies over the years. Ceramic insulators have been gradually replaced with polymer (HTV SIR) composite insulators in most Transmission Lines but polymer coatings have also been used in some special cases. The current state of the network (insulator-wise) is presented in this paper, along with past experience, the pollution profile of the island and the latest research steps, focused on monitoring and testing of polymer insulators removed from the network, in TALOS High Voltage Test Station and in collaborating labs.

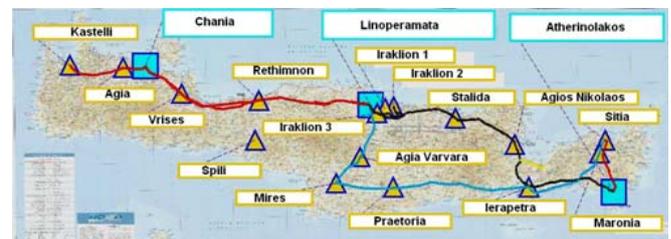
Figure 1. The power system of Crete. Squares denote step-up substation/power plants and triangles denote step-down substation.

Crete is a rather elongated Mediterranean island (260 km long and 15-60 km wide) and has a mostly rocky coastline of 1046 km. The transmission voltage level used is 150 kV. The development of the network has followed the general scheme of coastal development met in the island, as shown in Figure 1. As shown, the majority of all substation and TLs routes are in proximity to the coast and this fact combined with local weather conditions (prolonged dry period, strong winds etc) results to severe pollution problems [4]-[6], [9]. In fact, pollution was historically the single factor responsible for more faults in the 80s (32.5%) and 90s (19.6%) [9].

It should be noted that from 1978 to 1993, 216 faults took place in eastern Crete and just 1 fault (not pollution related) in western Crete, although extensive cleaning activities were performed only at the eastern side [10]. Further research in recorded faults data from 1994 to 2013 shows a similar picture as shown in Table I. The majority of faults have been recorded eastern of Iraklion (246 out of 307, i.e. 86%), with only 41 (13.35%) recorded in the TL connecting Iraklion to Chania and just 2 (0.65%) west of Chania. It should be noted that these are all the recorded faults (not only the pollution related ones) and also that the eastern routes include a double circuit (gradually upgraded in 2000-2004) in the Linoperamata-Agios Nikolaos-Atherinolakos route, denoted with a black line in Figure 1.

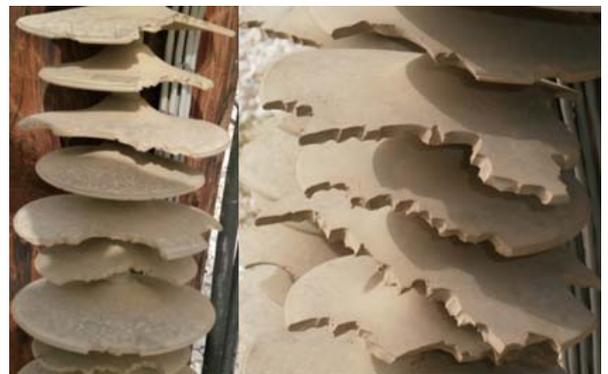
Figure 2. Polymer insulators attacked by birds

It should be noted that not a single pollution related fault had been recorded at lines equipped with HTV SIR. In 2014, two faults were recorded that were related with bird droppings and nesting and even though such faults (especially the one caused by bird droppings) may be considered as pollution related, the insulator material can hardly be considered responsible. It should also be noted that certain insulator batches seemed to be rather attractive to big birds as shown in Figure 2. This was dealt with following a trial/error method using different batches (hardness and color seemed to play a major role in the bird's liking) and also through the use of ceramic coated strings, thoroughly presented later in the manuscript. In regards to the economic benefit, it has been calculated that the yearly cost of washing is slightly larger than the 1/5 of the cost of replacing (i.e. the cost of replacement is paid back in 4.7 years of washing) [11].

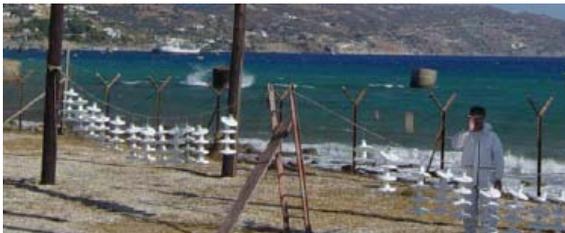
Figure 3. HEDNO personnel coating suspension insulators with RTV SIR

RTV SIR coated insulators have also been used in certain 150 kV towers when special conditions are met [13]. These insulators were coated by PPC/HEDNO personnel (e.g. Figure 3) and the first coating took place in 2004. The metal parts were also coated in order to avoid corrosion problems. RTV coated glass strings have been used in the upper phase of certain towers of the Ierapetra-Atherinolakos TL where clearance issues did not allow the use of the available composites. They were also used near the archeological site of Knossos and near the Iraklion 2 substation. In both these cases it was decided to use metal posts instead of towers mostly to avoid visual pollution complaints (especially in the case of Knossos) and also due to space limitations (especially in the case of Iraklion 2 premises that fall in the city grid of Iraklion). Originally ceramic insulators were installed in these posts but complaints for noise pollution were made, as the hollow metal posts magnified the buzzing noise related to minor activity. Most importantly, a high failure rate was observed (47 shattered units out of 1300 in 3 years) [12]. Therefore, the ceramic insulators installed in these poles (glass strings and long rod porcelain) were coated on site, which resulted to both these problems being solved.

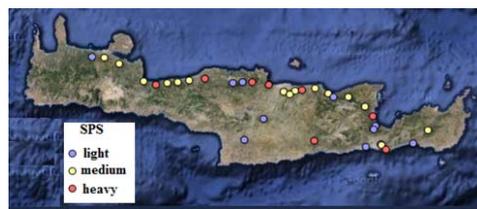
Figure 4. SPS classes as acquired via ESDD measurements

For the purposes of the POLYDIAGNO research project, composite insulators were to be removed from certain network towers, some of them to be installed in TALOS and others to be sent for lab evaluation. To decide the location of the towers, prior experience along with previous pollution measurements (Figure 4) [4] were considered. The years in service and also some practical issues (tower location, ease of removing etc) were also considered. It should be noted that the considered ESDD measurements were conducted on site using dead insulator strings hanged from the metal structure of 150 kV towers [4]. However, as glass and porcelain strings of fog and disc profile were used to acquire the measurements, a correlation factor has to be defined in order to provide a unified image. Currently the worst-case-scenario value proposed in the literature has been used [4] but comparative ESDD measurements have been conducted in a specially designed arch in TALOS, shown in Figure 5, which will provide a more accurate value when published.

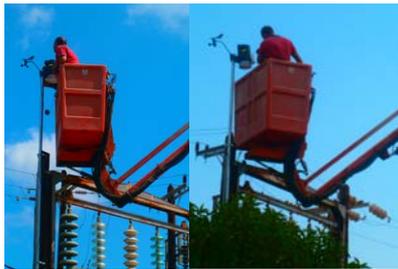
Figure 7. Installation of the weather station in top of the ESDD arch

The monitored leakage current, weather and pollution will provide a complete profile of the stress that these insulators were subjected at. A stand-alone weather station has been suitably installed in top of the ESDD arch as shown in Figure 7 and an online weather report is currently publicly available in the station's site [15]. The leakage current measurement is acquired by using a stand-off insulator to lead the current to a hall sensor. An explosive fuse is used to protect the equipment and to enable the disconnection of a particular insulator, e.g. in case of a flashover, without interrupting the supply to the other insulators. Sensors and measuring devices are housed in a cabinet for protection and ease of access. Drawing and photos are shown in Figure 8.

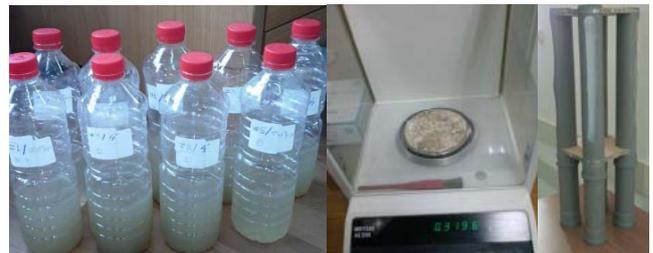
Figure 10. Labeled bottled with the remaining solution after ESDD measurements, the precision scale in HEDNO's chemistry lab weighing a dried filter, and the result of a first attempt to fabricate a DDDG measuring kit

An NSDD measurement set up has also been established in the recently refurbished chemistry lab of HEDNO in Iraklion 2 substation. ESDD measurements are conducted in TALOS and the acquired solutions are then carried in bottles to the chemistry lab in Iraklion 2, as shown in Figure 10. Further, as a future step, it was decided to fabricate DDDG measurement kits and a photo of a first prototype is also shown in Figure 10. For the exact procedure followed for ESDD, NSDD and DDDG measurements see [2].
