# Insulation Coordination and Pollution Measurements in the island of Crete

**Abstract**—The performance and reliability of outdoor dielectrics used in power systems is strongly linked to local environmental conditions. A major factor affecting their performance is the pollution severity in the area along with local climatic conditions. Sea is considered a major pollution source and therefore coastal installations and islands usually face severe pollution problems. The Mediterranean island of Crete provides a rather interesting case study as the particular conditions met there have resulted to the island being a reference point on both national and global scale. The Greek utility has employed several different remedies to cope with the pollution problem over the years. Pollution measurements have been performed throughout the island in order to acquire a pollution map to assist in insulation coordination and maintenance. Measurements have been performed on un-energized insulators similar to the ones used in each area/tower at that time. However, as both material and profile play an important role on the actual pollution impact, comparative measurements have also been performed in

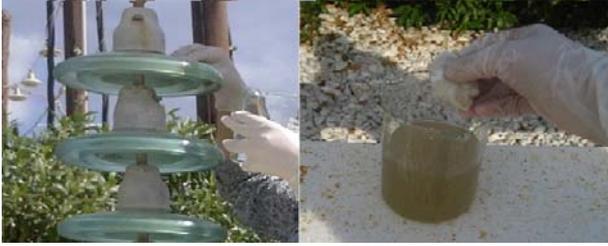
Fig. 1. Measuring ESDD on site

In this method the contaminants of an insulator's surface are carefully removed with a cotton swab, excluding any metal parts or assembly materials (Fig. 1). The contaminants are then dissolved in distilled water of 100-300 cm<sup>3</sup>, stirred and then the conductivity and the temperature of the solution are measured (Fig. 2). ESDD is finally estimated from the volume of the solution, the area of the cleaned surface and the corrected to room temperature (20°C) conductivity [1, 2, 13]. ESDD is a

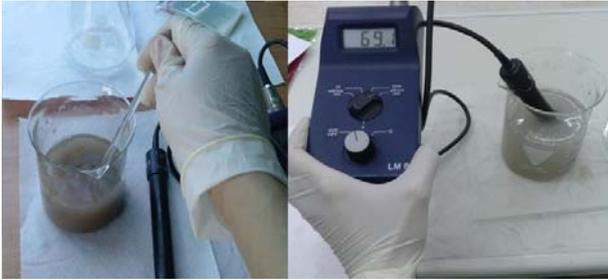
Fig. 2. Measuring the conductivity of the solution

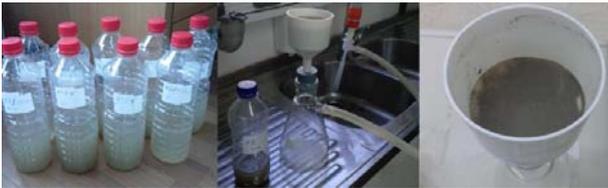
Fig. 3. Solutions into labeled bottles, filtering with water vacuum pump and residuum on the filter paper

In order to acquire the NSDD measurement, the ESDD solution shall be filtered by a pre-dried and weighed filter paper. Then, the filter containing the pollutants shall be dried and weighed again to calculate the weight of the non-soluble deposits [1, 2, 8]. NSDD can not be performed on site as it is a time consuming technique that requires special equipment such as a water vacuum pump, a drying oven, a desiccator and a precision scale. The Chemistry Lab of HEDNO (Hellenic Electricity Distribution Network Operator) provided the necessary equipment to perform the NSDD measurements in this case. The solutions used, were carried to the laboratory into labeled bottles as shown in Fig. 3. The drying oven, desiccator and scale used are shown in Fig. 4.

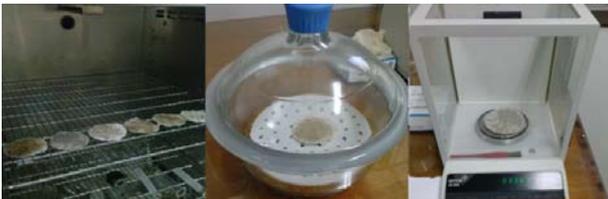
Fig. 4. Filters in the drying oven, desiccator and precision scale

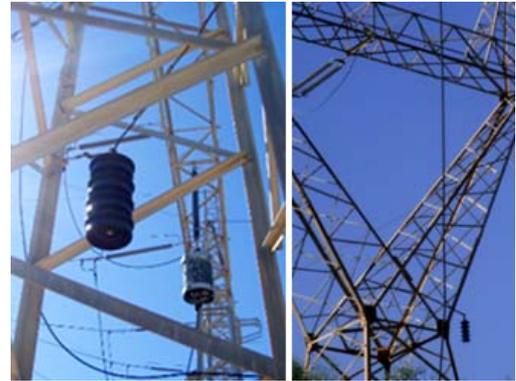
Fig. 5. Dead strings hanged from the metal structure of towers

In order to investigate insulators' behavior under natural contamination conditions and the pollution severity along the island, a series of ESDD measurements were conducted throughout the network. Four periodical measurements took place in yearly intervals as the required by [2] monthly visits were rather impractical and time consuming for the line crew. Considering that the measurements took place after the end of summer (September-October) and before any rainfall, they should provide a good approximation to the worst-case pollution scenario (i.e. the SPS). The strings of insulators were hanged from the metal structure of 150 kV towers (Fig. 5) in 35 spots throughout the Cretan power system (Fig. 6). Each dead string was composed of five ceramic (porcelain and glass) discs, hanged from a lower height in order to be easily accessible. Disc and fog profile insulators were used for these measurements. The location of the 35 150kV towers where the specimen insulators were hanged is mainly residential and marine polluted areas, the majority of them being at the central and eastern part of the island, as shown in Fig. 5. The mentioned specimens are shown in Fig. 7 and their characteristics are presented in Table I.

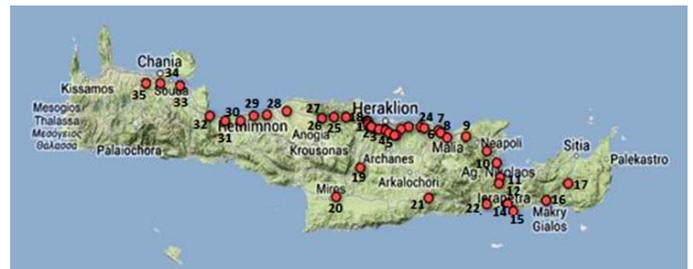
Fig. 6. Location of the specimen insulators

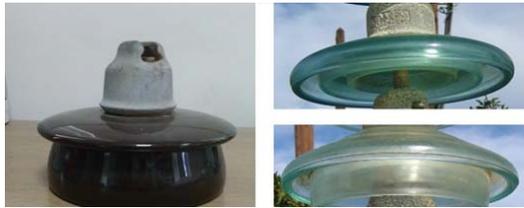
Fig. 7. 150 kV specimen insulators

Insulator Profile/Material	Creepage Distance (mm)	Shed Diameter (mm)	Shed Area (mm <sup>2</sup> )
fog/porcelain	430	267	252,700
disc/porcelain	310	254	164,900
fog/glass	390	255	201,300
disc/glass	310	254	164,900

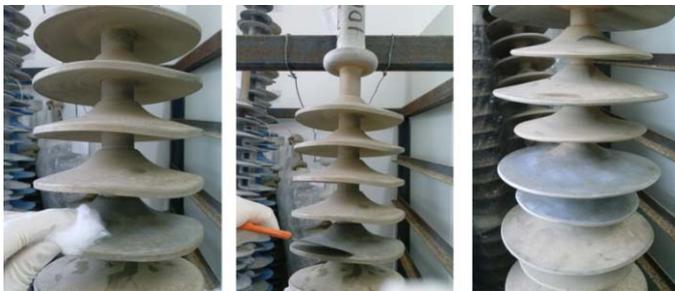
Fig. 8. ESDD measurement on a HTV-SIR insulator removed from the network

The largest part of Crete's TLs is coastal and for that reason subjected to intense marine pollution. The pollution problem is rather exaggerated on the eastern side of the island, as the frequent rains on the western side resulted to no particular problems experienced there [3-4]. In order to cope with the problem, the most heavily influenced TLs were equipped over a decade ago with HTVs and most of the rest followed recently [7, 9]. Recently, additional ESDD and NSDD measurements were conducted on polymeric insulators that were removed from TLs after a long time service period. The specific TLs are Linoperamata-Mires, Mires-Ierapetra, Linoperamata-Chania and Linoperamata-Ierapetra and their route can be found in [7, 9]. As the value of an insulator's surface area was not provided by the manufacturer, Computer Aided Design (CAD) had to be employed to design 3D models for each insulator in order to calculate the required values. The characteristics of the mentioned RTV-SIR insulators are shown in Table II. In Fig. 8, the surface pollutants of an HTV-SIR insulator are removed by cotton and a spatula and the different view between the two wiped sheds compared to the others which is shown in the third picture.

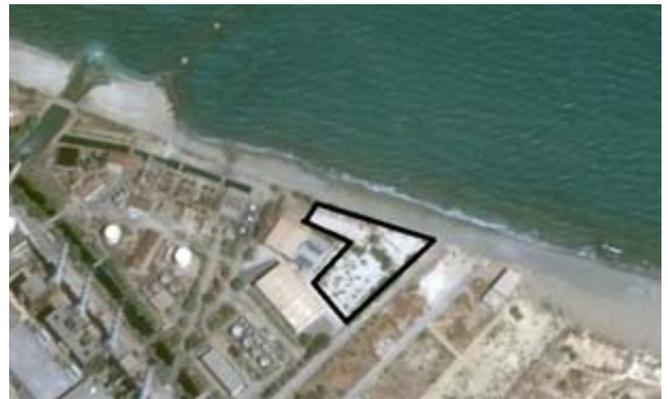
Fig. 9. The location of TALOS High Voltage Test Station

Comparative ESDD and NSDD measurements were also conducted on insulators of TALOS High Voltage Test Station in Iraklion, Crete [14]. TALOS is a research and testing center west of the city of Iraklion, near a 150 kV substation [6, 15]. As shown in Fig. 9, it is located next to the coast in order to be subjected to maximum marine pollution [6, 15]. TALOS is divided in three different sections: 150 kV post insulators section, 150 kV suspension insulators section and 21 kV post and suspension insulators section. Also, it is equipped with a specially designed arch, where five different types of suspension insulators are hanged offline. The specimens used are: a Teflon long rod insulator, a fog profile glass insulator, a fog profile glass insulator coated with RTV-SIR, a disc profile glass insulator and an HTV-SIR long rod insulator (Fig. 10).

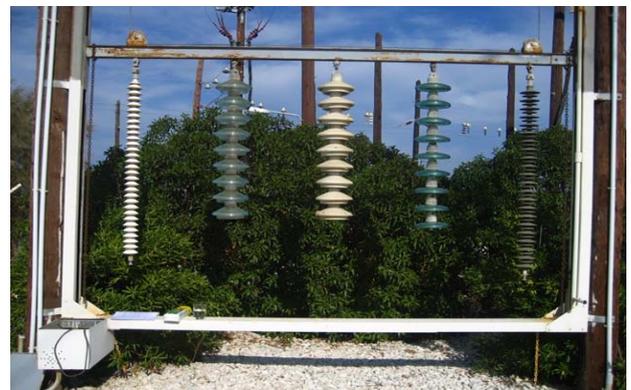
Fig. 10. Specimen insulators in the lowest position of the ESDD arch

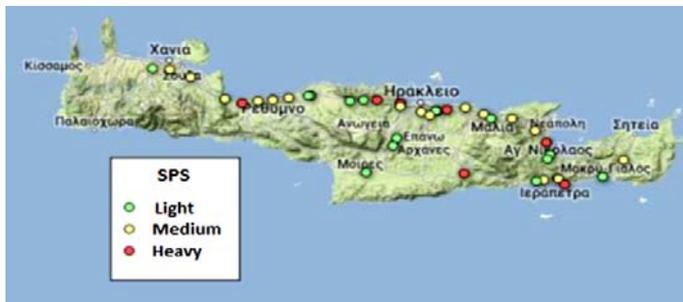
Fig. 11. Pollution map of Crete

Fig. 11 shows the final pollution map of the island of Crete, according to CIGRE limits, after the described field tests and after the application of the correlation factor calculated through the comparative measurements. As it is obvious, areas near big cities (Iraklion, Rethimnon, Agios Nikolaos and Ierapetra) have high pollution levels, with the results proving that the proximity to pollution sources and coast is a key factor for pollution levels. However, the city of Chania is an exception as the pollution recorded there is milder probably because of the frequent rains, almost twice the rainfall compared to the eastern part [3-4]. Also, the lighter pollution of the coastal sites in the south part should be attributed to the prevailing direction of the wind which is north-west [3-4]. These facts verify the reason why the majority of the remedies employed have always been focused on the eastern side of the island.
