Expanded Test Station Helps Greek Power System Operator Assess Insulator Design & Performance

INMR Contributor, Raouf Znaidi travels to Crete to meet with HEDNO engineers and reports on their efforts to combat pollution flashover.

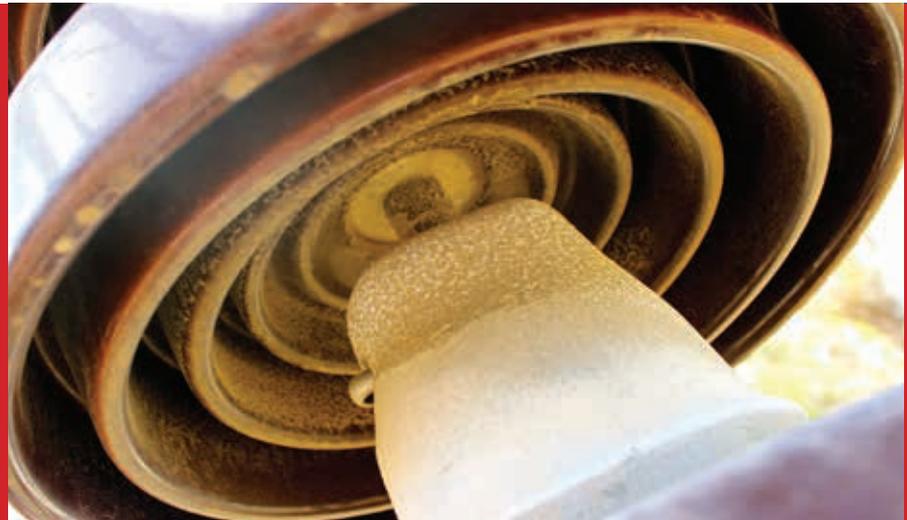
Table 1: Outages Affecting Key Lines on Crete 1994 to 2013

Chania-Kasteli	2
Linoperamata-Chania	41
Linoperamata-Agios Nikolaos-Ierapetra	117
Linoperamata-Mires-Ierapetra	72
Linoperamata-Iraklion 2	31
Ierapetra-Atherinolakos-Sitia	44

The annual dry season starts in April and lasts until the end of October. Over these months, there is steady accumulation of pollution – mostly salt mixed with industrial and agricultural pollutants – that deposit onto insulators and become wetted by high humidity, dew and salt spray from the surrounding Mediterranean. The combination of contamination build-up and rapid onset of wetting often result in pollution flashovers on the most exposed lines. For example, some of the worst years, such as 1985, saw up to 25 outages recorded per 100 km/year – a level that dealt a serious blow to the island's important tourist industry. Table 1 shows the number of outages

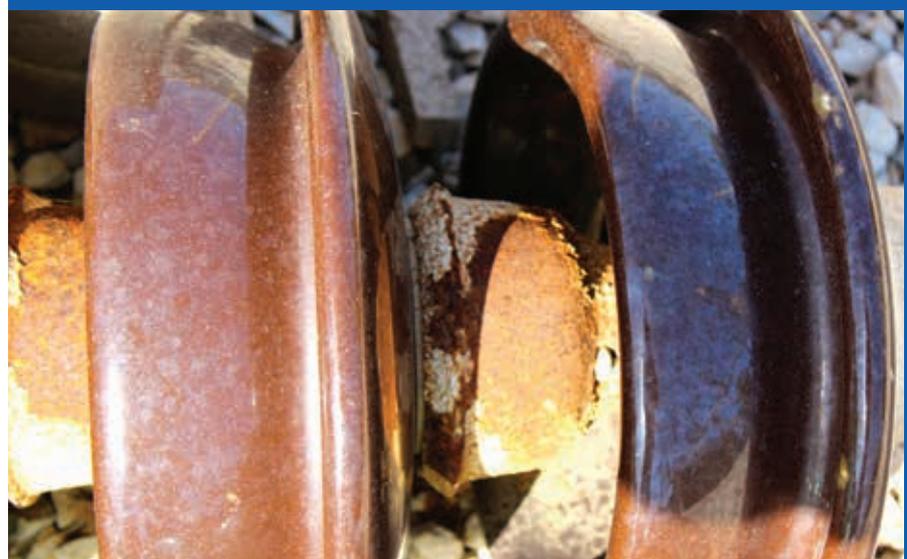
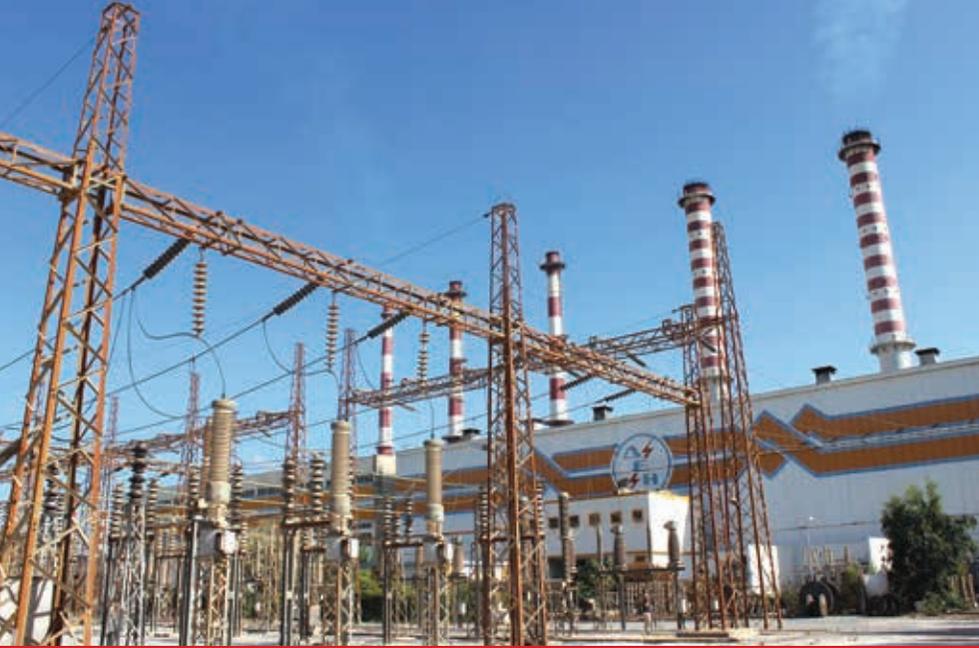
Examples of pollution and corrosion affecting porcelain cap & pin insulators on Crete.

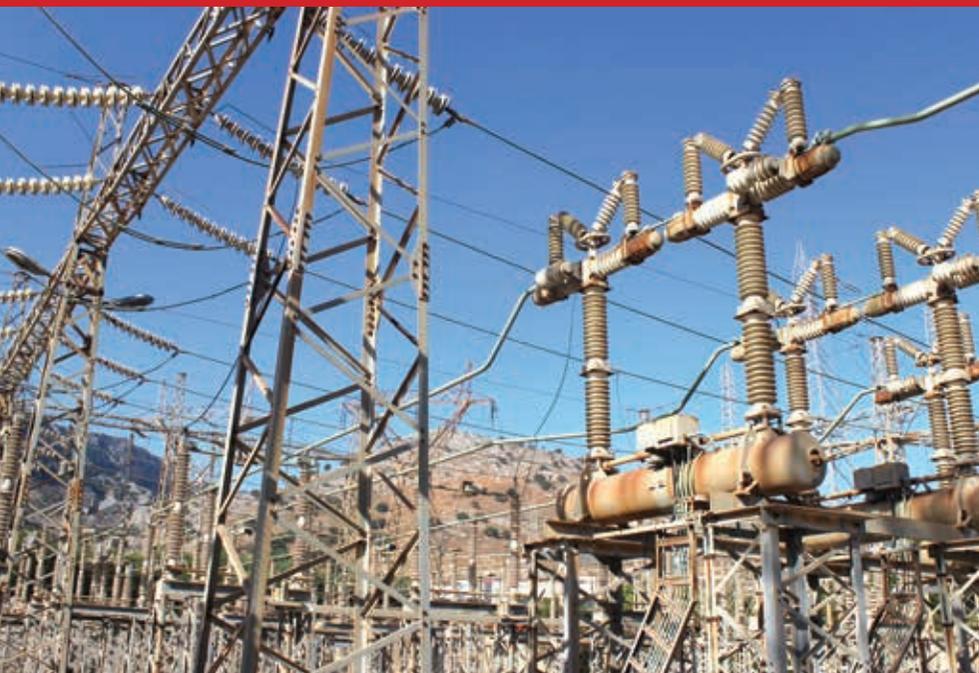
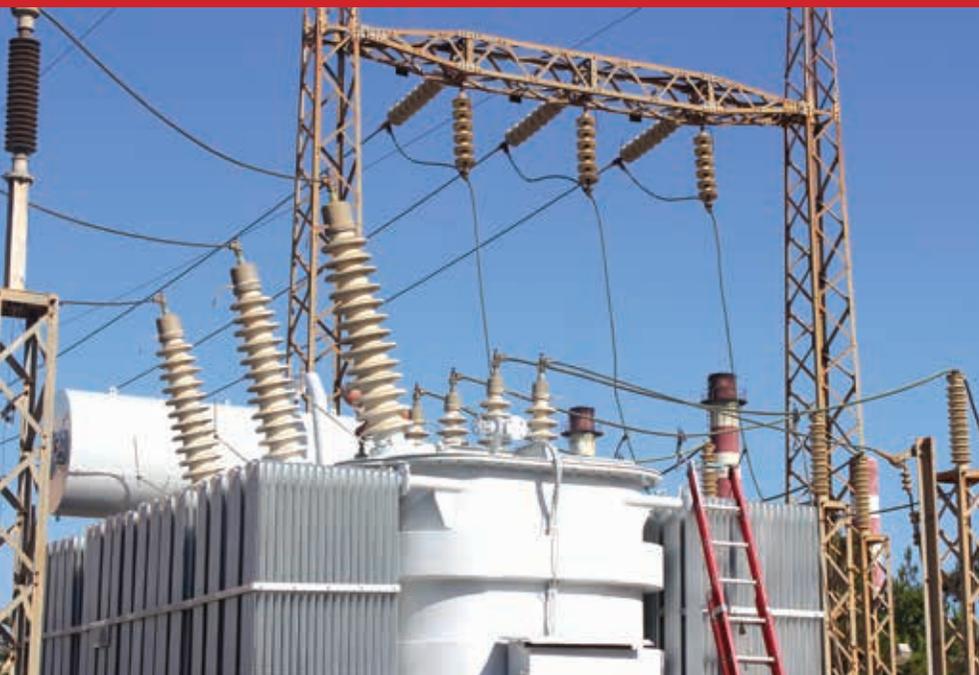
Views of Linoperamata Power Plant show insulators coated with RTV silicone and also impact of corrosion on equipment. Transformer at right in process of being sprayed with special anti-corrosion coating.

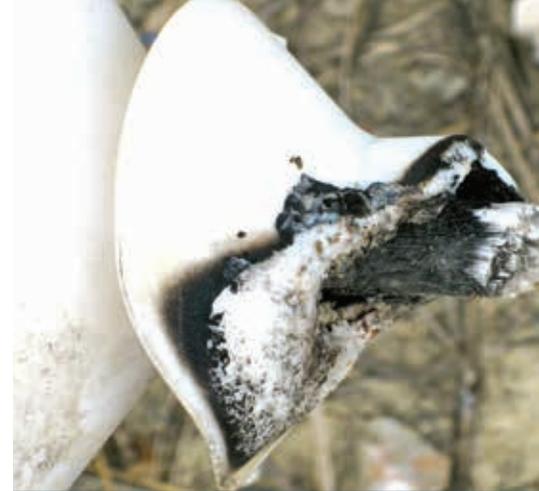
Fracture failure of Teflon insulator once used on Cretan power network.

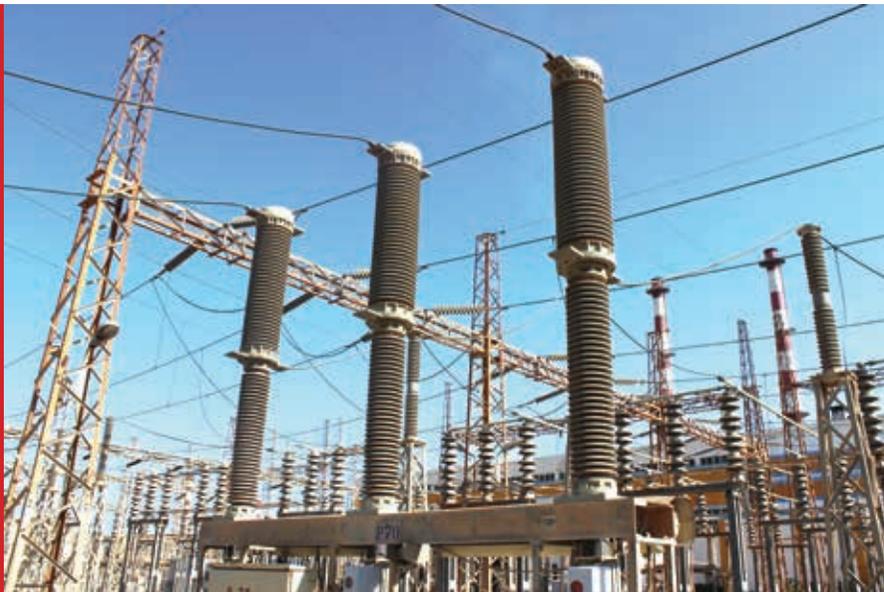
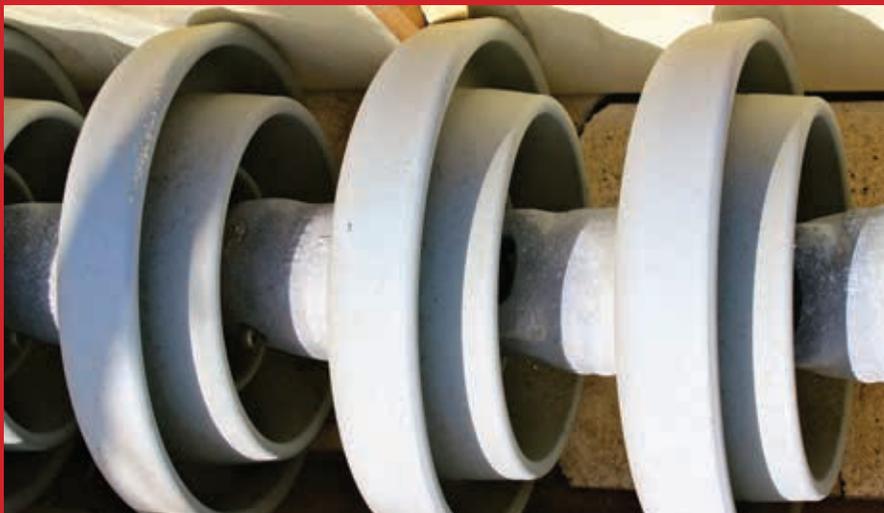
Alternative formulations of RTV silicone coatings have been applied to line and substation insulators to establish which perform best.

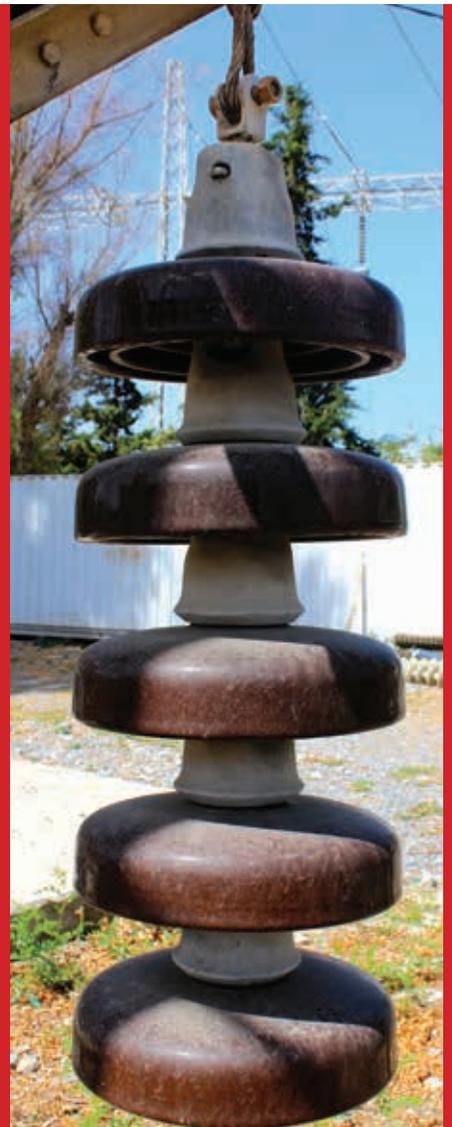
Non-energized string on selected towers used to collect ESDD and NSDD measurements.

ESDD & NSDD measurements taken before the onset of the first autumn rains. Conducted in cooperation with HEDNO line crews, data has been gathered using non-energized porcelain cap & pin insulators hung on 33 HV towers scattered across the island. These locations have been selected so as to cover most of the different service conditions and local microclimates.

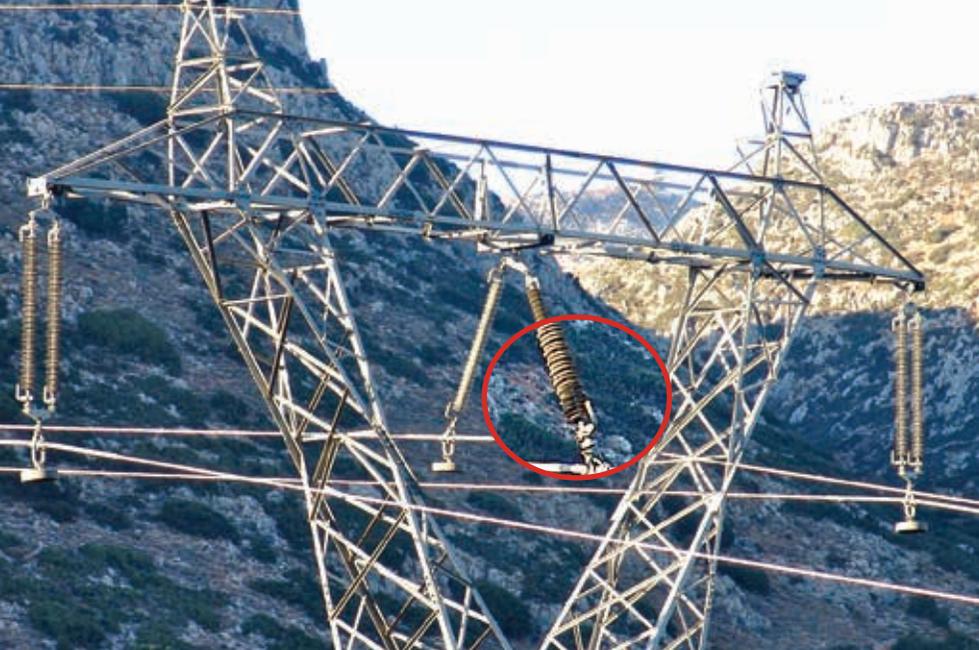
Line in heavily polluted northeast Crete insulated with silicone insulators. Note that one unit installed on middle phase has blackened near live end at time of photo (2008).

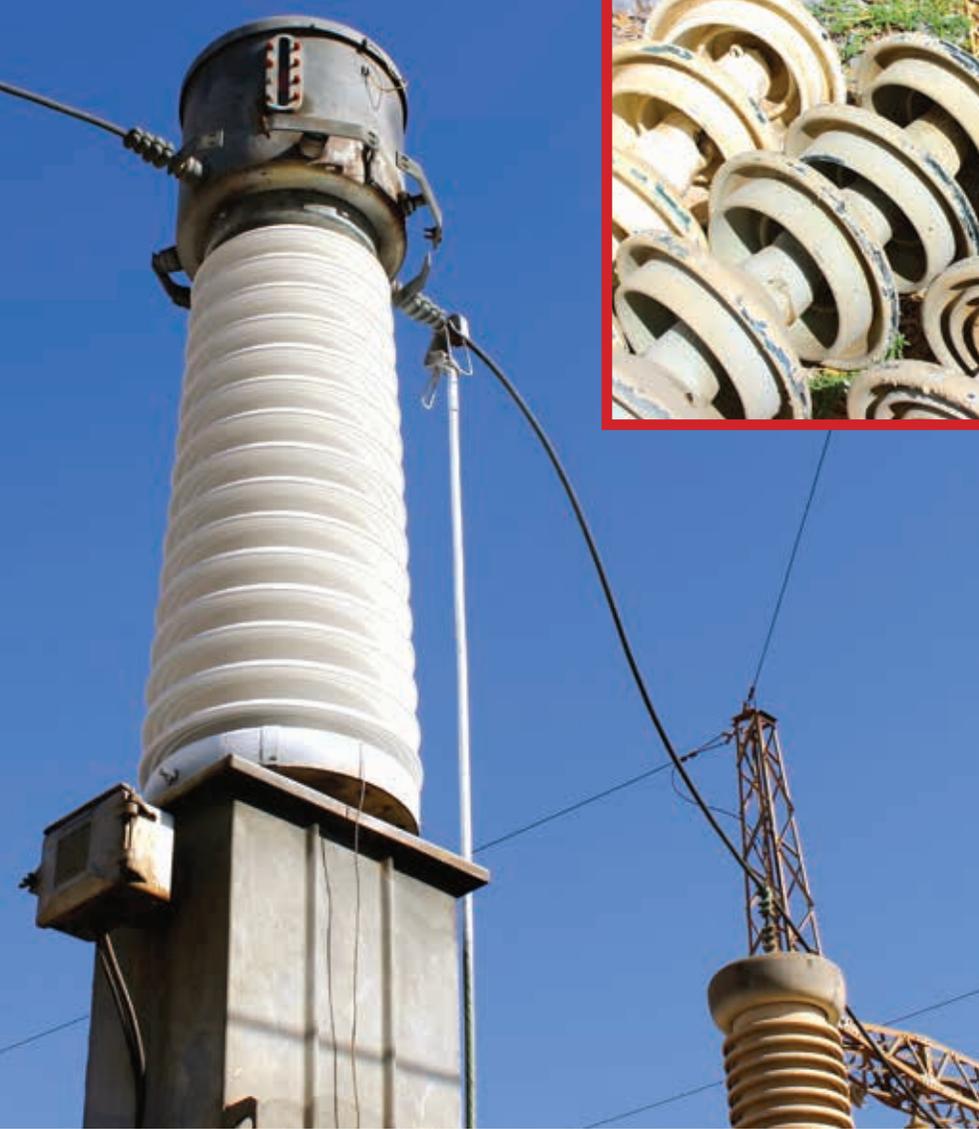
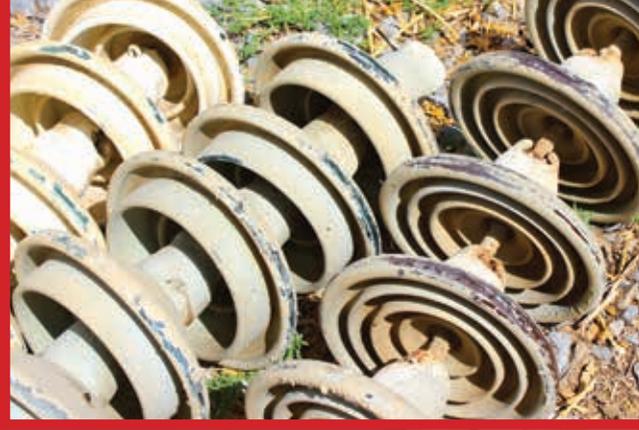
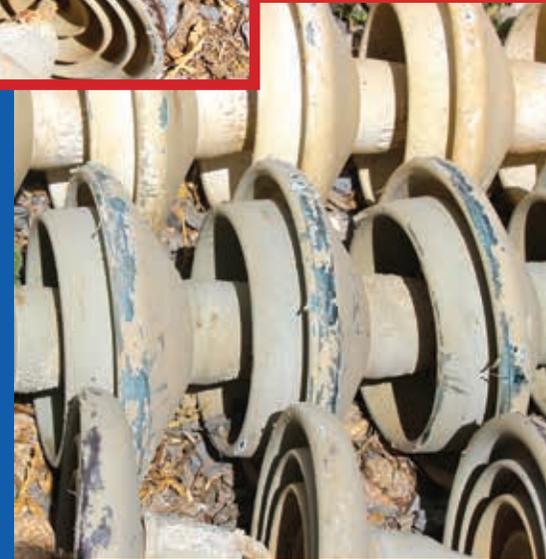
Newly coated CT at Linoperamata. Condition of coatings on cap & pin insulators periodically removed from service.

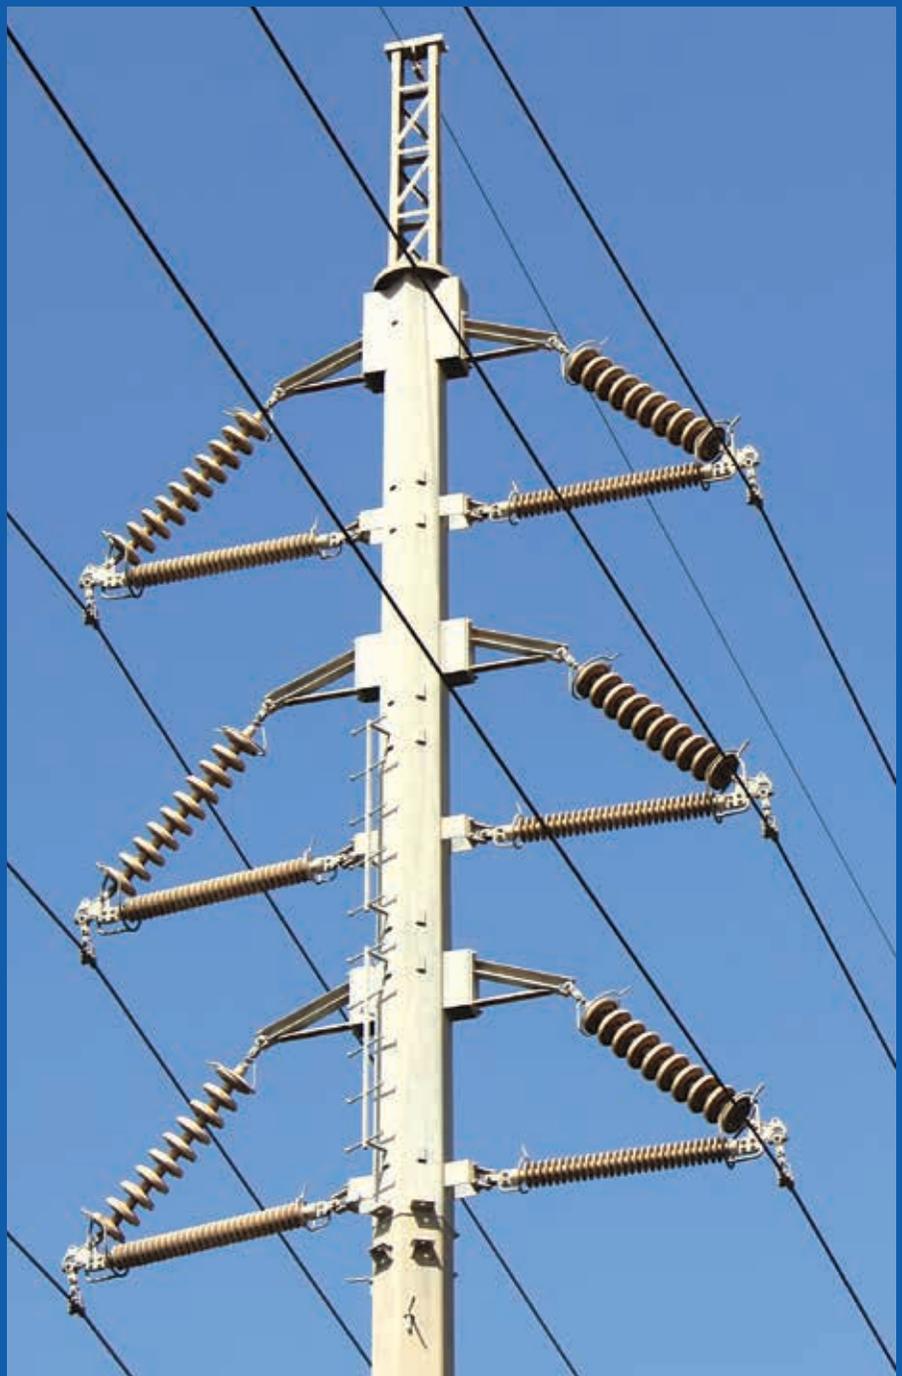
Insulators on 150 kV tower near downtown Iraklion coated to control discharge activity and noise.

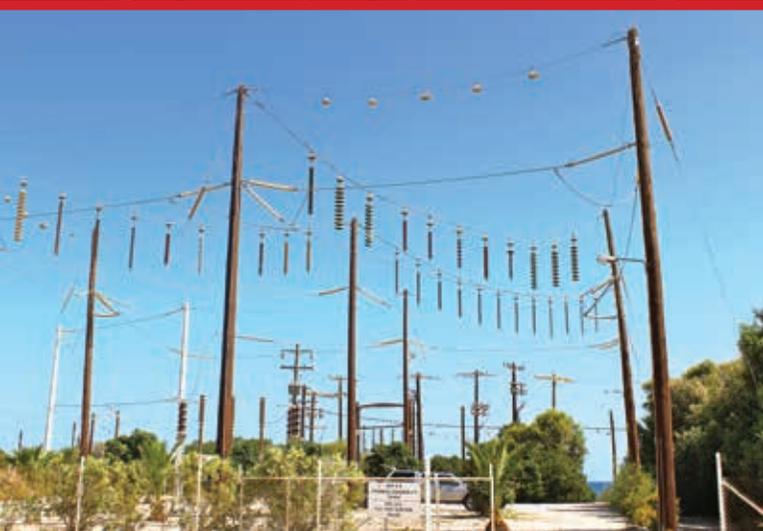
Talos Insulator Test Station recently expanded to 150 kV.

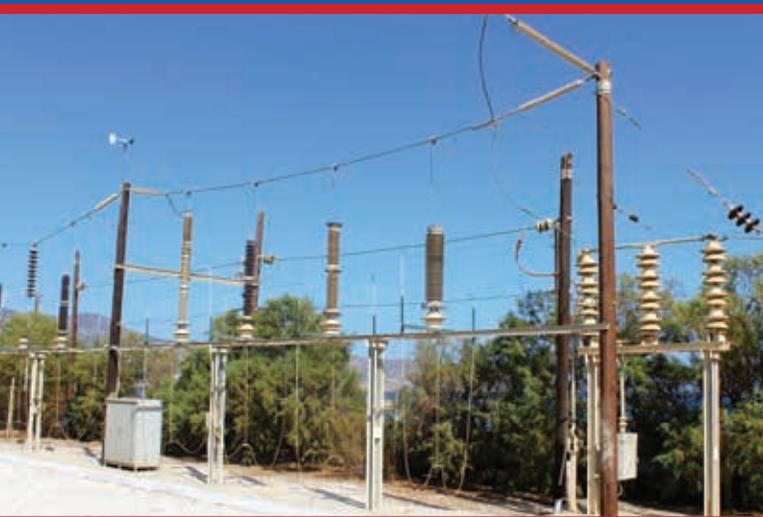
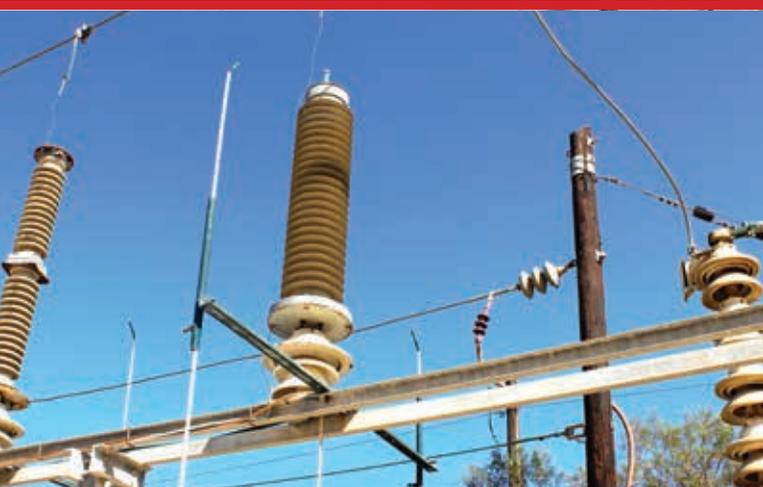
150 kV test bay at Talos devoted to post insulators.

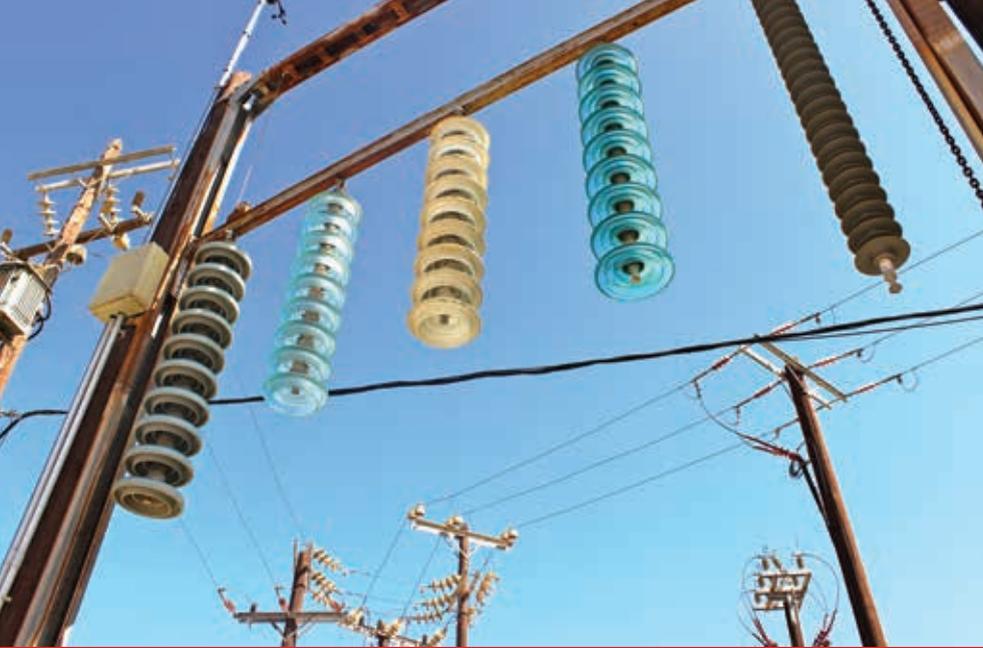
Device to allow comparative measurements of ESDD and hydrophobicity on non-energized test insulators.

Apart from its three test bays, the Talos Test Station is also equipped with a locally designed power-driven gantry structure. Here, a variety of different types and geometries of non-energized insulators are hung at different heights to allow comparing pollution accumulation as well as measuring contact ESDD and hydrophobicity. The automatic up and down control on the structure allows for easy visual inspection of all test insulators, including the condition of RTV coatings, distribution of pollution along surfaces, ageing, etc.

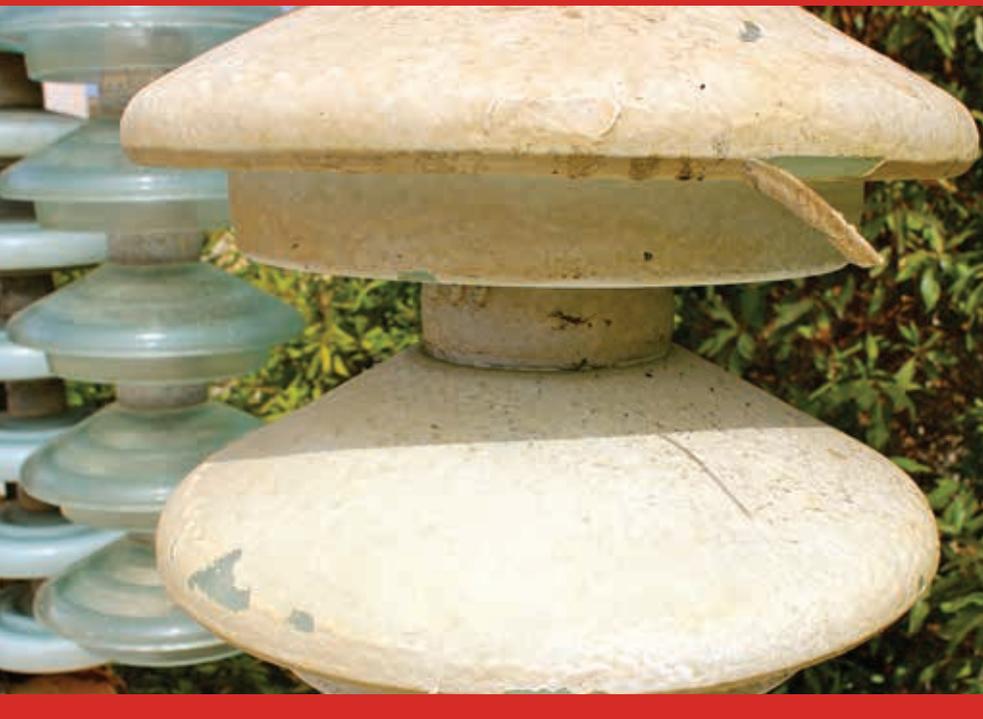
“The aim,” explains Pylarinos, “is to assess different post and suspension insulators under conditions of severe salt spray. This will permit more rapid detection of any hidden defects, poor design or premature ageing – especially in the case of composite insulators and RTV-coated insulators.”

Thalassinakis remarks that the Talos Test Station has the capacity to handle even more insulators for testing since it is equipped with extra stand-off insulators ready to support up to 20 additional specimens for pollution performance assessment. He regards the facility, which is the culmination of years of work, as an ideal platform to assess insulator performance under severe marine and industrial pollution and also to monitor ageing phenomena under such contamination exposure. “We are also open,” he says, “to develop any kind of co-operation or technical assistance either with insulator manufacturers or with other power system operators who face similar difficult environmental conditions to those here on Crete.” ☒

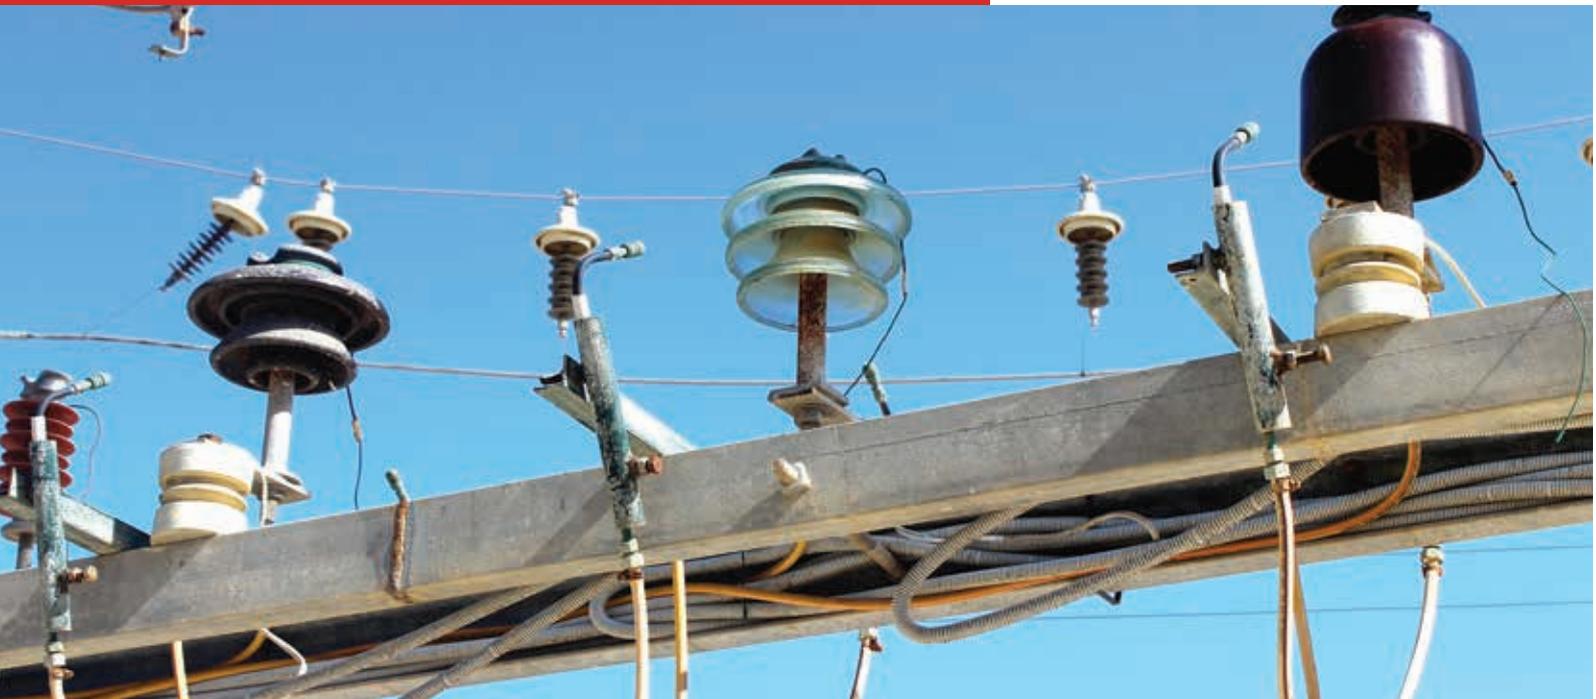
Spray nozzles directed toward specimen insulators permit accelerated testing to detect surface discharges and hot spots.

Another feature at Talos, notes Thalassinakis, is that video cameras have been installed at strategic locations around the test station. Their goal is to monitor any surface discharge behavior and allow an observer in the nearby main control room to record their evolution. The facility is also equipped with a spray installation offering adjustable levels of salinity. For example, nozzles are directed toward the bodies of 21 kV and 150 kV post insulators and observation identifies the formation of hot spots on test insulators under normal service voltage or under accelerated testing with added salt spray.
