Co-operation with Local Academia Delivers Benefits for Greek Power Utility

For example, a cornerstone joint research effort between a power utility in Greece and local academia – POLYDIAGNO – has been co-financed by the European Union as well as the Greek National Fund. In this case, the goal behind the co-operation between the Hellenic Electricity Distribution Network Operator (HEDNO/PPC) and the Technological Educational Institute of Crete (TEIC) as well as the Foundation for Research & Technology (FORTH) has been to evaluate ageing mechanisms of different naturally-aged composite insulators removed from service under severe maritime conditions ~~XXXXXX~~ ~~XXXXXX~~. INMR contributor, Raouf Znaidi, reports on the scope and some of the initial findings of this collaborative effort.

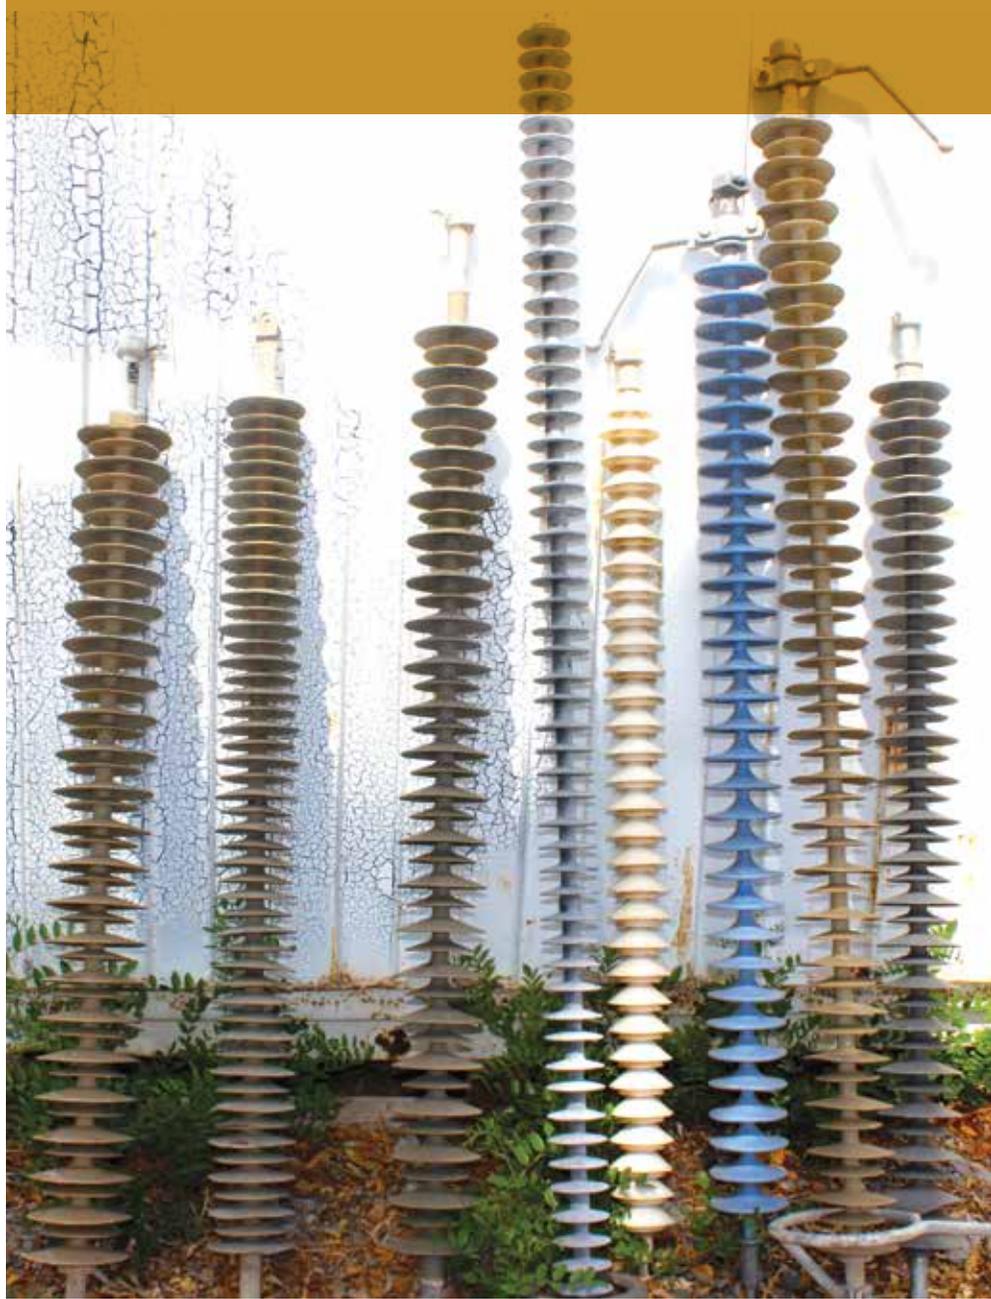
Siderakis reports that, prior to HV testing, a combination of visual inspection as well as qualitative hydrophobicity classification measurements were performed on each of the naturally aged composite insulators removed from 150 kV lines. The most commonly observed defects were signs of ageing such as surface discoloration and degradation of sheds and, in some cases, severe corrosion of metal fittings and hardware.

Selection of 150 kV composite insulators removed from service.

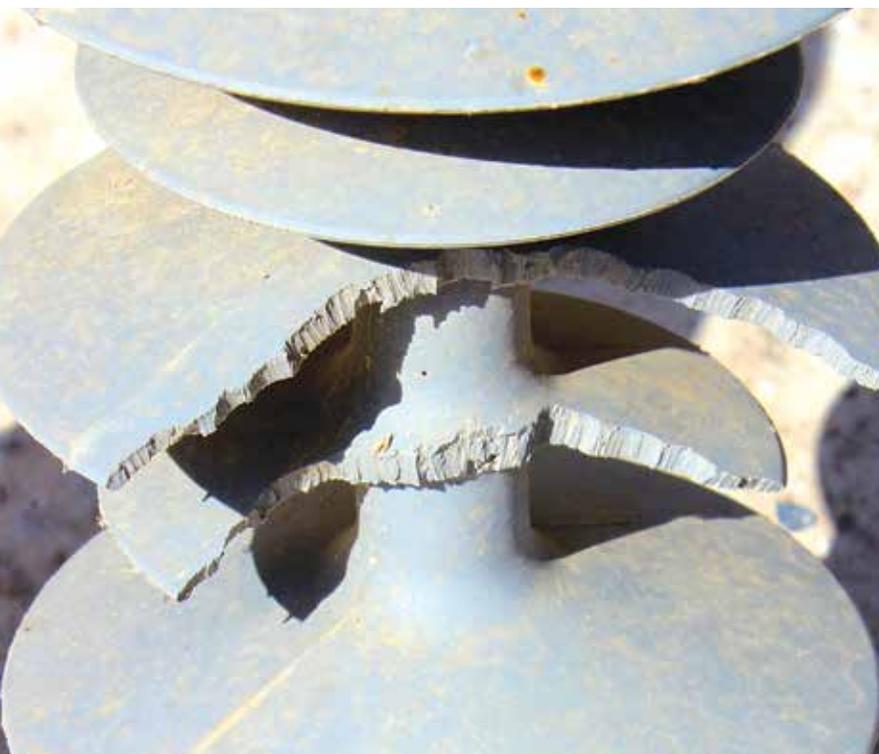
There were also several units provided by HEDNO that forcefully demonstrated what could happen if a composite is not handled properly during storage or transport to a site. In this case, either partial or even complete destruction of several sheds were attributed to attack by birds or, given the scale of damage, more likely rodents.

Severe damage to several sheds attributed to attack by wildlife.

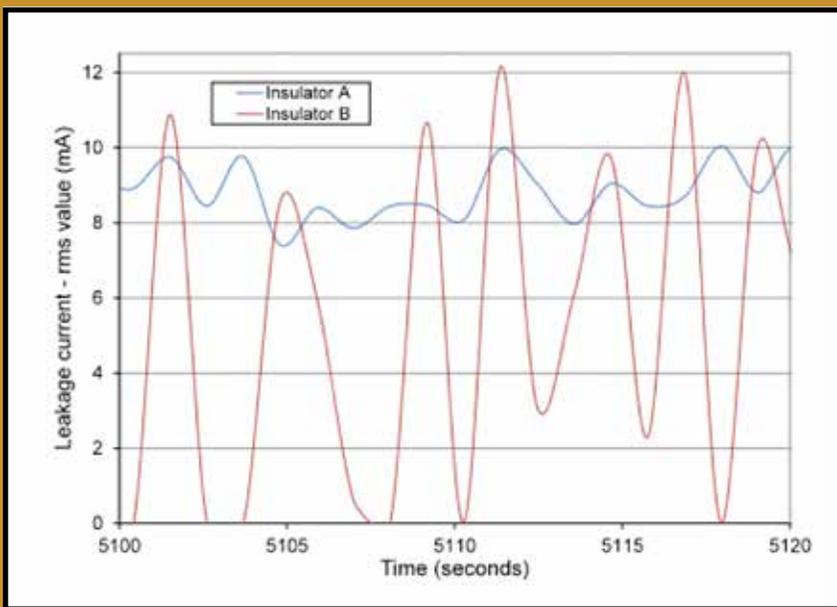
Fig. 1: Leakage current measurements of naturally aged insulators.

An example of findings from the leakage current monitoring of one sample (A) cut from a field-aged composite insulator, showed that the highest average RMS value fell in the range of 45.6 mA (see Table 1). Figure 1 depicts continuous leakage current activity registered for samples A and B and associated with partial discharge activity.

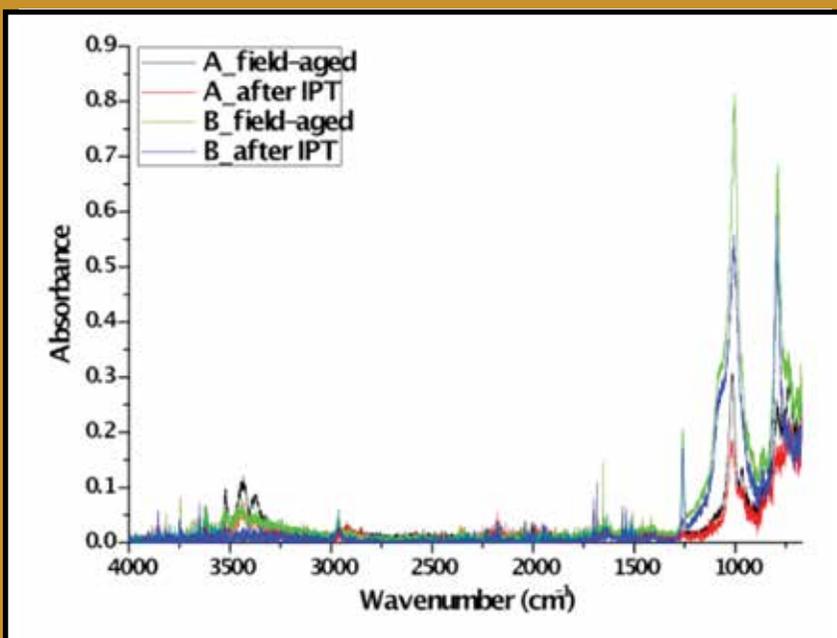
Fig. 2: Comparison of composite insulators prior to and after IPT tests.

PhD candidate, Nikos Mavrikakis, is closely involved in this research and has performed many of the inclined plane tests (IPT) based on IEC 60587, as now recommended for assessing new polymeric materials. He states that its application to naturally aged insulators, such as in this case, can provide valuable additional information on resistance to tracking and erosion as well as expected remaining service life.

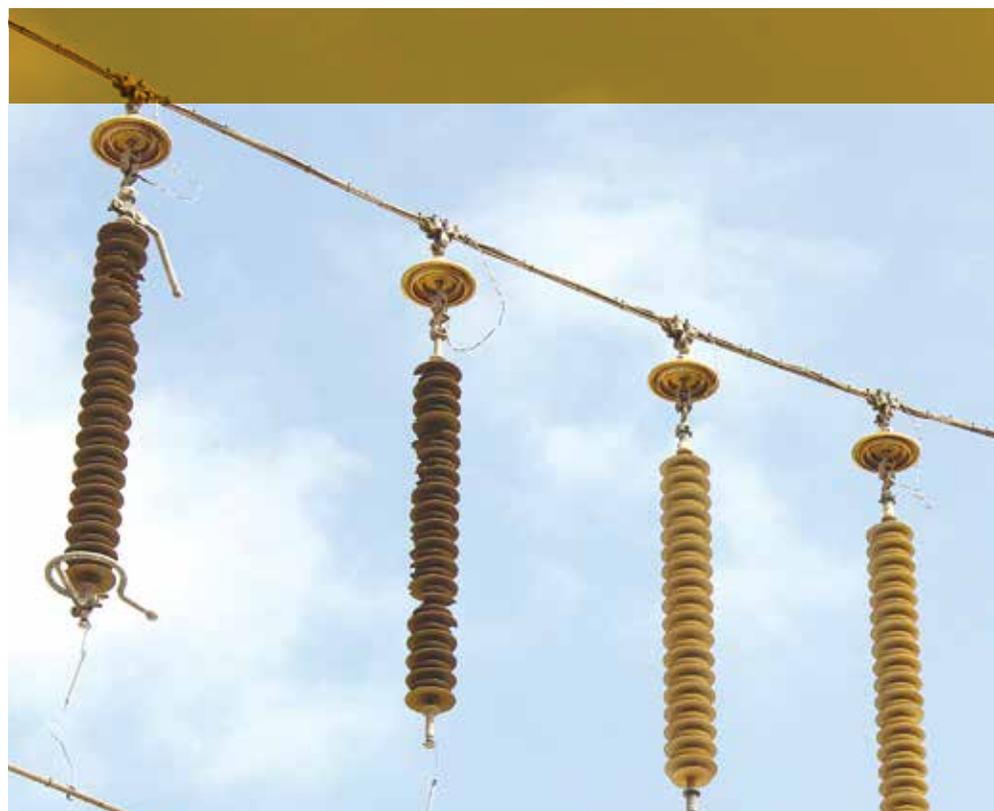
Examples of degraded insulators hung at Talos Test Station.

Consultant Dionisios Pylarinos explains the process by which lines workers at HEDNO identify target insulator specimens to be removed from lines and transferred to TEI for in-depth evaluation. Says Pylarinos, “crews have conducted close field inspection as well as hydrophobicity measurements of insulators. Based on this, they have already taken down 21 specimens from 7 different towers along the 150 kV network. According to defined selection criteria such as location, number of years in service and localized pollution severity, one of each different design of composite insulator was sent for electrical testing. The remaining 14 units were subsequently installed at the Talos test station, to be taken down at prescribed intervals for complementary analysis and diagnostics.”
