Comparative study on field collected samples of aged silicon rubber composite coatings for high voltage insulators

Keywords: HV insulators, RTV SIR coatings, aging, characterization.

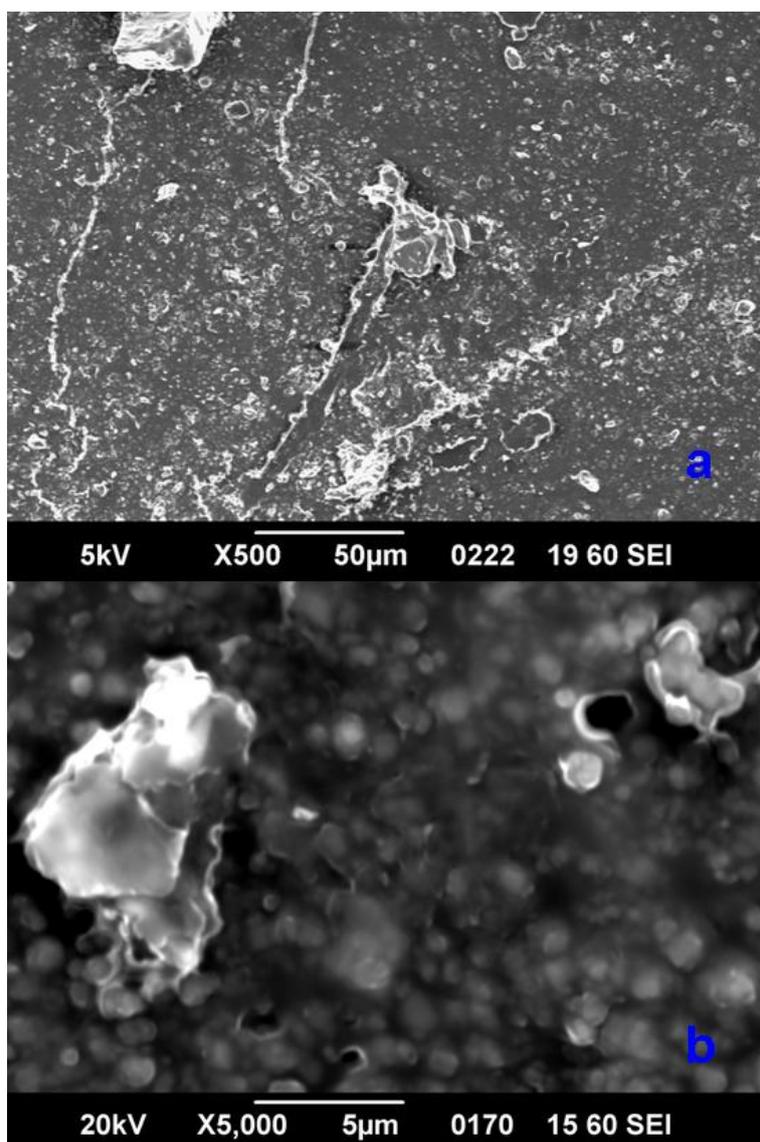
Reference sample: Figure 1 presents surface morphology of a virgin SIR HTV sample at two different magnifications and electron acceleration voltages. Higher magnification reveals the filler material distribution in the silicon rubber matrix.

Figure 1. LV-SEM image of reference SIR sample a. general view ($\times 500$ at low acceleration voltage 5kV) b. close up evidencing the filler material ($\times 5000$, 20kV).

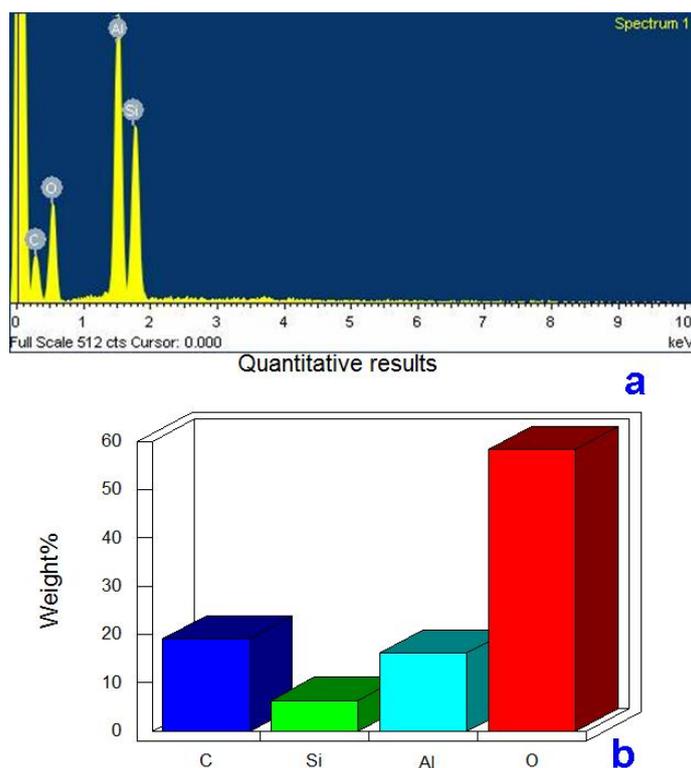
Compositional characterization of SIR sample shows the presence of C, Si, Al and O elements in the proportions presented in Figure 2b. A characteristic EDX spectrum corresponding to this sample is presented in Figure 2a.

Figure 2. Compositional characterization of SIR sample a. EDX spectrum; b. elemental composition (weight %).

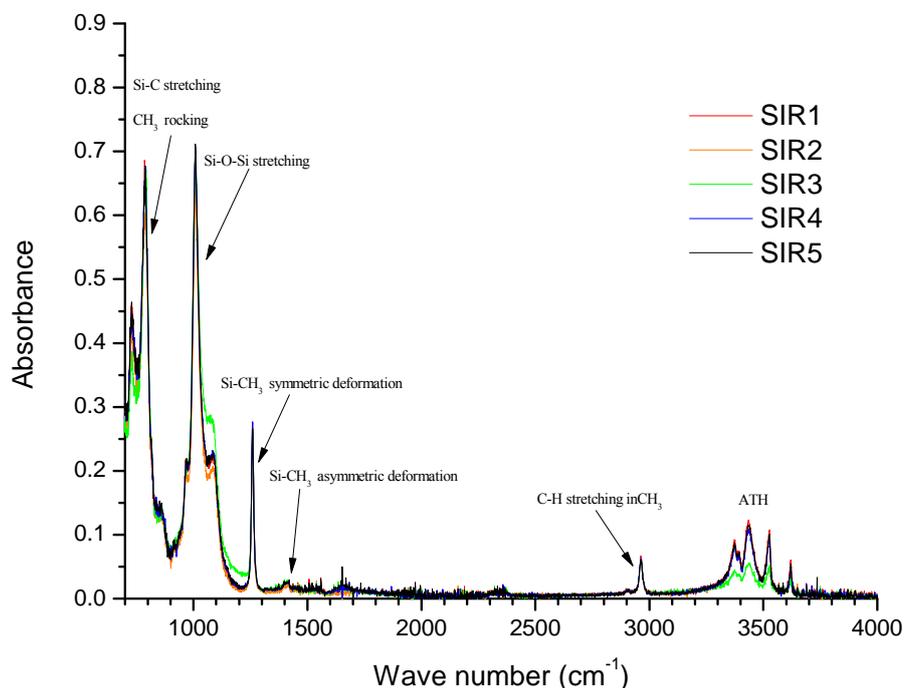
ATR FT-IR characterization was performed for the reference sample and different artificially aged samples since the target of the study is monitoring and degradation control. These are used to set-up a reliable characterization procedure in order to overcome experimental difficulties due to low control of sample thickness when sampling is done in the field from the HV outdoor insulators. The absorbance vs. wavenumber (cm^{-1}) spectra for five reference samples SIR are presented in Figure 3 and Table 2 together with the area of the peaks for Si-O-Si stretching and Si-CH₃ symmetric deformation since these peaks can be correlated with the backbone of the polymer and its hydrophobic properties respectively. It is expected that during degradation processes the polymer will suffer methyl group losses due to oxidation and surface mineralisation and correspondingly the band at 1261.61 cm^{-1} will drop in intensity while the

bands corresponding to backbone stretching (1020.47 and 1091.85 cm^{-1}) will increase in intensity due to cross-linking and surface mineralisation.

Figure 3. ATR FT-IR spectra corresponding to virgin SIR HTV sample and four artificially aged samples.

Since the area of the peaks is directly related to the concentration of a group in a given material the ratio of two peaks is equal with the ratio of the absolute quantities of the investigated molecular components. Based on this we can see how a molecular composition changes during degradation. In case the polymer is oxidizing the normalized ratio is expected to grow due to the fact that more Si-O bonds are formed while the methyl groups transform in other products. In case the backbone of the polymer brakes forming lower mass products the Si-O peak will drop thus decreasing the normalized ratio. If a sample has silica as a filling material the results are difficult to interpret since the lower mass molecules are migrating toward the surface modifying the ratio in a random fashion. Based on the above, we may assume that the SIR samples degrade by oxidation.
