# Insulators' pollution problem: Experience from the coastal transmission system of Crete

N.C. Mavrikakis, and  
E. Koudoumas  
Electrical Engineering  
Department, Technological  
Educational Institute of Crete,  
Heraklion, Crete, Greece  
koudoumas@staff.teicrete.gr

K. Siderakis, D.  
Pylarinos, and  
E. Thalassinakis  
HEDNO S. A. Islands  
Network Operation  
Department, Heraklion,  
Crete, Greece  
k.siderakis@dieddie.gr

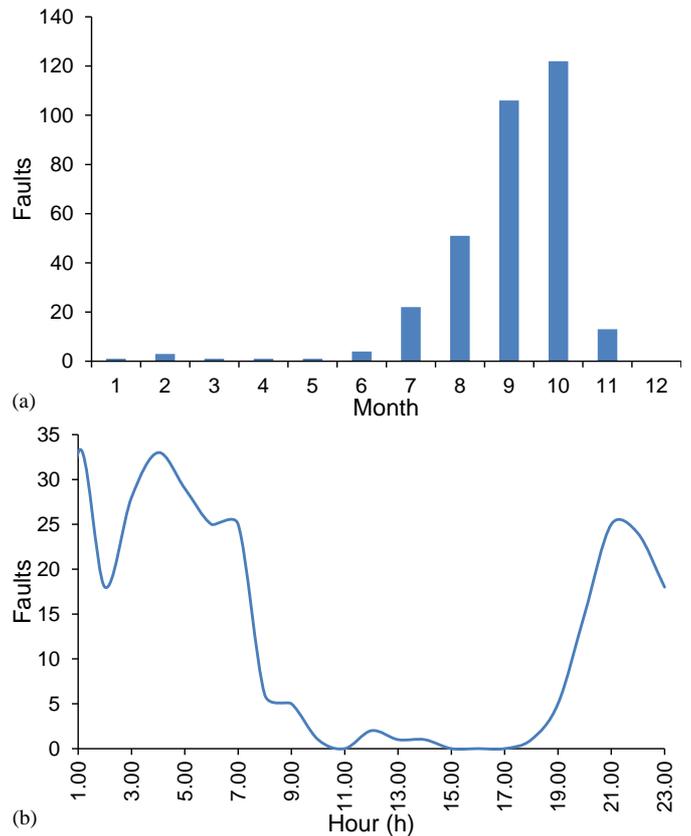
Fig. 2. Number of pollution faults (a) per month and (b) per hour from 1969 to 2002 [8]

The insulators' pollution problem can be analysed using the data of the pollution power outages since 1969. Fig. 2(a) presents the total number of faults in transmission lines caused by pollution per month, the respective faults per hour shown in Fig. 2(b), for the period 1969 to 2002 [2]. It is demonstrated that the great majority of pollution faults occurred, mainly from September to October during the night or early in the morning (Fig. 2(a) and 2(b)). The strong marine winds in dry period (summer months) are able to transfer great amount of sea borne pollutants, spraying the insulators installed close to the coastlines. Following, the prolonged dry summer period without rainfalls, favours the large concentration of pollutants on insulators' surfaces.

Immediately after the end of the dry period, a wet period of high humidity, especially in the morning and during the night, follows. Then, the accumulated pollutants, high in salinity due to sea salt pollutants, are diluted. A high conductive layer is formed on the insulators' surface, which under certain conditions can lead to flashover. For the other months of the year, pollution faults occur rarely, since the natural cleaning effect of the winter rainfall period follows. Finally, the greater number of the pollution faults in the eastern side of the transmission system is directly attributed to the stronger summer winds towards this direction as well as the lower frequency of rainfalls.

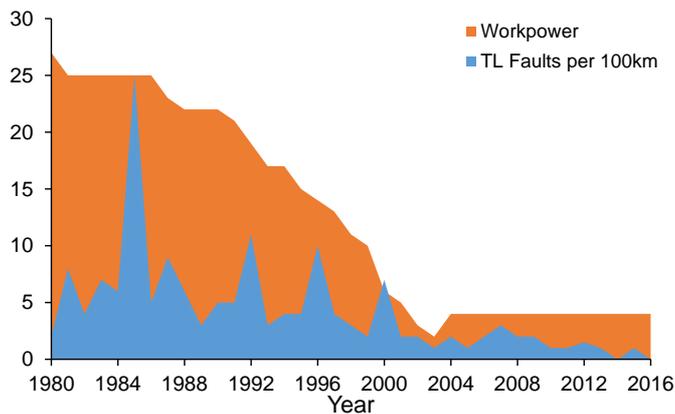
Fig. 3. Transmission line faults from 1980 to 2016 per 100 km

The maintenance practices, described in this study, were mainly employed for the ceramic insulators already installed in the overhead high voltage transmission lines and outdoor substations on the island. Fig. 3 shows the number of total faults per 100 km of the 150 kV transmission lines and the number of the workpower from 1980 to 2015. Although the required number of workpower is considerably reduced, the system reliability is increased and maintained in a desired level for more than 15 years (2000 – 2016), which is a result of the effective maintenance procedure. The maintenance practices which have been applied since 1978, are described below.

as well as long-lasting electricity interruptions of the transmission system were required during the washing procedure. The sponge washing was last performed in 1981 [4], [9]. For the next 3 years, from 1982 to 1985, the insulators' washing stopped. This decision was finally resulted to a sharply increase of insulators pollution failures in 1985 [2], [4], [9]. After that, it was clear that the maintenance practices had to be performed on a periodical basis to ensure the reliability of power system.

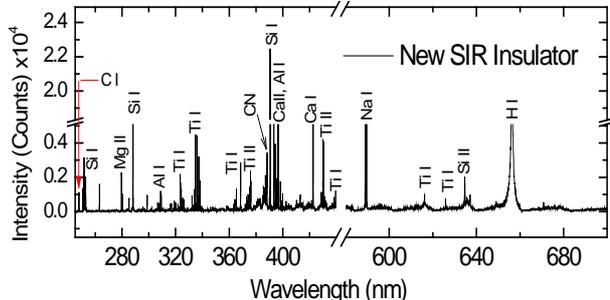
Fig. 8. LIB spectrum of a new SIR insulator (Nd:YAG laser;  $\lambda=1064$  nm) The spectrum is an average of 10 single-shot spectra.

A typical LIB spectrum of a SIR insulator is shown in Fig. 8. The major emission lines detected are those of Si, Al, Ti, Mg, Ca, Na and H. Although C atomic emission (at 247.8 nm) is hardly distinguishable, CN molecular emission band is detected at relatively high signal-to-noise ratio. CN molecule is formed in the plasma, upon the reaction of C with the atmospheric nitrogen [23] and its detection indicates that the housing material is organic in nature. Strong Si atomic emission denotes that the polymeric housing is PDMS. Also, Na may be derived from sea-borne pollution deposited on the insulator surface. The rest of the elements, detected, originate from the fillers, which are inorganic compounds such as MgO,  $Al_2O_3 \cdot 3H_2O$  (ATH),  $TiO_2$  and  $CaCO_3$ . The results demonstrate that the housing material of the insulators, examined herein, is either SIR or EPDM, in agreement with ATR-FTIR spectroscopic measurements.
