Performance investigation of composite and RTV SIR coated insulators at a coastal test station

Index Terms—Composite insulator, field testing, leakage current, RTV SIR coated.

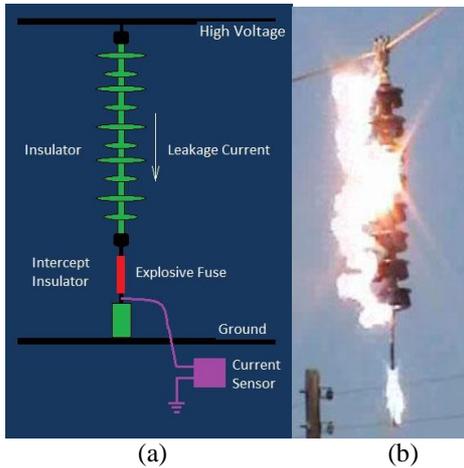
Fig. 2. (a) Installation set up including the connection of the explosive fuse (b) operation of the explosive fuse in the case of a flashover.

In addition, considering that flashovers will be often, in an effort to achieve continuous operation of the test station, each insulator is equipped with an explosive fuse [11]. Thus in the case of a flashover, the operation of this fuse will disconnect the considered insulator from the power supply and the reclosing feature of the employed circuit breakers will ensure the station operation. In the pictures of figure 2 the connection of the explosive fuse to an insulator under test (figure 2a) and the fuse operation in a case of a flashover are illustrated (figure 2b).

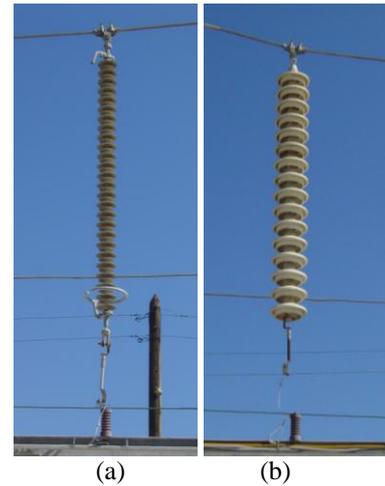
Fig. 3. Insulators under test: (a) Composite HTV Silicone Rubber insulator and (b) RTV Silicone Rubber coated glass insulator.

The insulators included in this test are used in the 150kV transmission system of Crete, on the same transmission poles. Both provide hydrophobic surface behavior and thus improved pollution performance but also the coated ceramic insulator is employed in an effort to reduce the insulator axial length for the same leakage distance. The insulators tested are illustrated in figure 3 and their features are included in table 1.

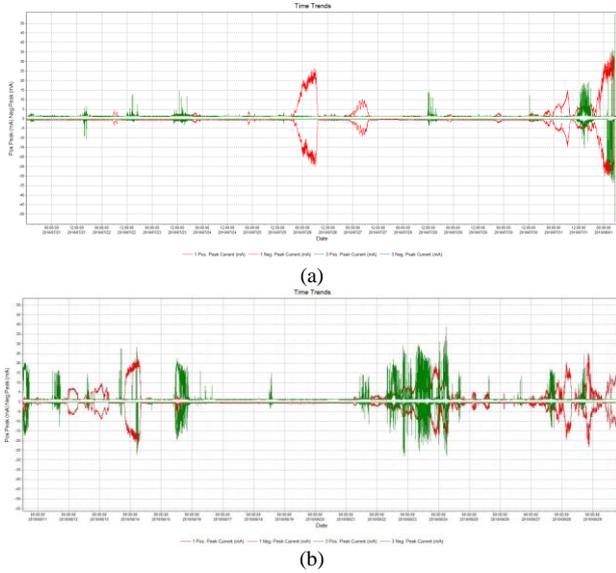
Fig. 4. Peak values of leakage current during (a) Period A and (b) Period B. (red line: composite insulator and green line RTV SIR coated glass)

The data included in this paper correspond to a 60 days test, during July and August, two months with intense pollution problems for Crete. The measurements are presented in two periods, period A and B, which are in time sequence and a small maintenance period is interpolated between them. The peak values of leakage current, for the periods demonstrating activity within the test and for the insulator with the maximum activity (of each type), are illustrated in figures 4a and 4b respectively.

Incidents of activity have been recorded on both insulator types. The levels of current peaks are similar for both insulators. However the incidents of activity are not always simultaneous and the type of activity appears to be different. In the case of the composite insulators, surface activity appears to be continuous, while on the RTV SIR coated ceramic a train of intermittent current peaks has been

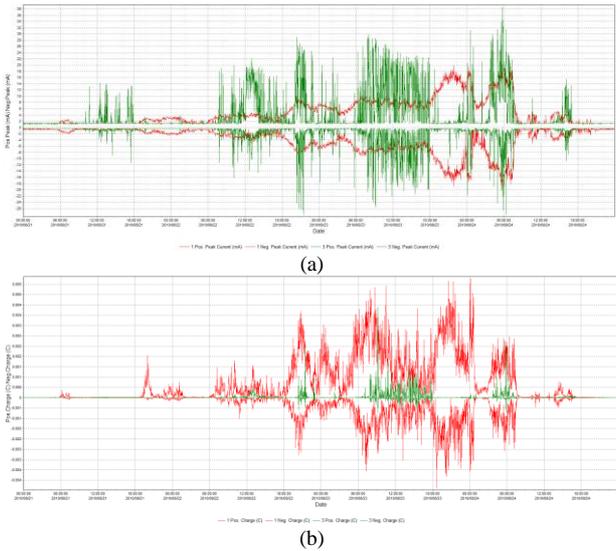
Fig. 5. (a) Peak values of leakage current during an incident of intense activity. (b) calculation of the surface charge for the waveforms of (a). (red line: composite insulator and green line RTV SIR coated glass)

recorded. This is evident in both periods, even in cases where the levels of activity on the coated insulator are higher than on the composite. Such an incident is illustrated in figure 5a. In addition in figure 5b the surface charge, calculated from the time interval of the current of figure 5a is illustrated.

The comparison of figures 5a and 5b reveals that although the peak values of leakage current indicate increased levels of activity on the ceramic insulator, the calculated surface charge reverses this indication and the activity appears to be more intense on the composite insulator. This is evident for the majority of the activity incidents recorded within the test, as illustrated in figures 6a and 6b, where the surface charge for the two time periods is presented.

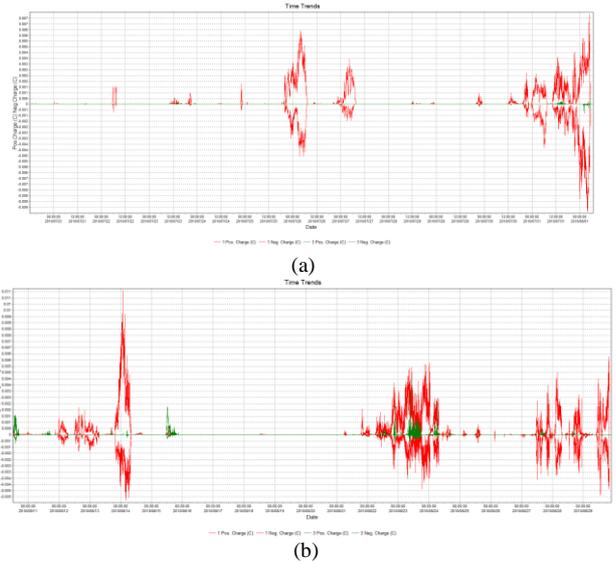
Fig. 6. Calculation of the surface charge for the periods of activity in (a) figure 4a and (b) figure 4b.

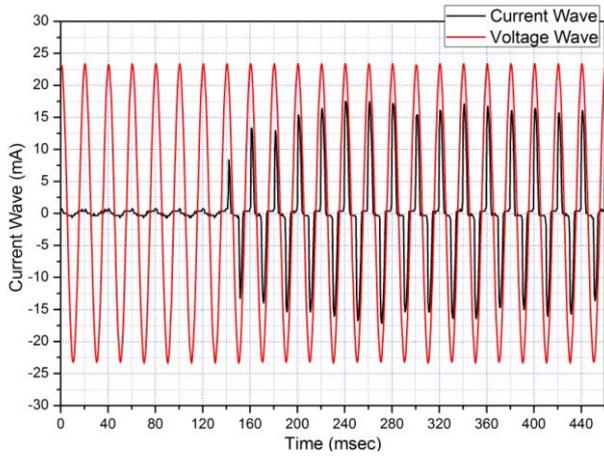
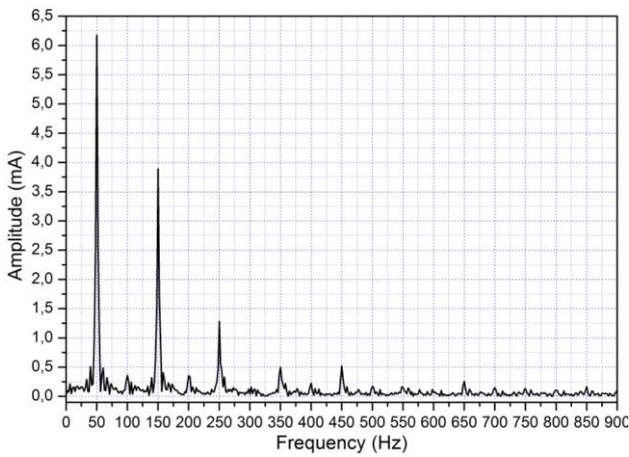
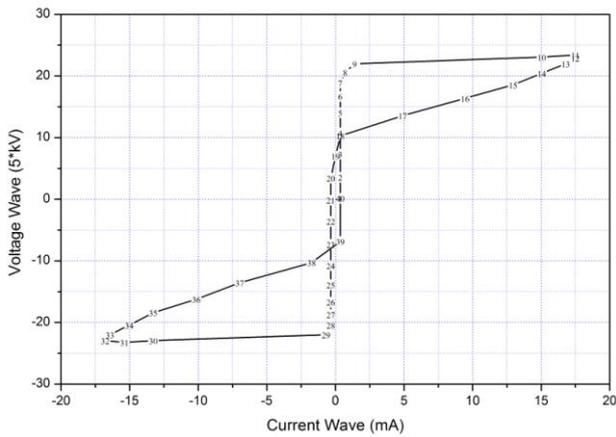
Fig. 7. Typical leakage current waveform on the composite insulator in the case of intense activity, (a) Leakage current and voltage waveform (b) FFT spectrum of the leakage current and (c) Voltage current characteristic for the period with the highest value of leakage current within the activity of (a).

Two typical leakage current waveforms, one for each insulator type are illustrated in the following figures. They have been recorded within the incident of figure 5 and for each FFT analysis and the corresponding voltage current diagram have also been calculated. Figure 7 (a-c) are the waveforms and the corresponding diagrams for the composite insulator and figure 8 (a-c) for the coated ceramic insulator. The activity illustrated in figure 8a is similar to the activity experienced on a ceramic insulator. The FFT analysis verifies the non linear character of the current and the size of the third and fifth harmonic [13, 14]. Also the V-I character reveals the presence of a gas discharge along the current path [15]. Similar findings can be reported from the corresponding figures for the coated insulator (figures 8a-8c). In this case however the FFT spectrum is not clearly distinct as in the case of the composite insulator and the energy supplied to the discharge is less as it can be estimated from the area included within the hysteresis curve of the V-I diagram.

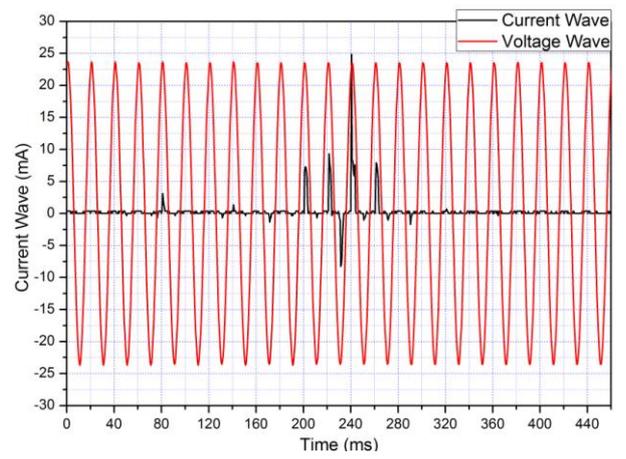
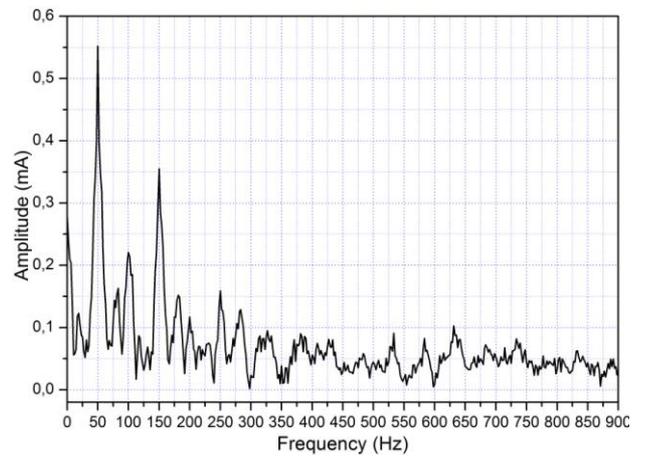
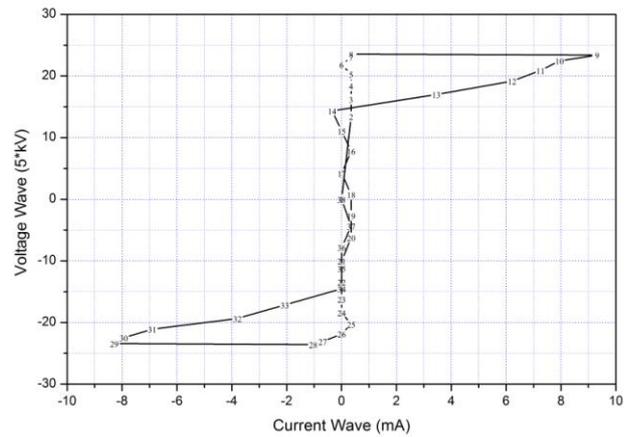
Fig. 8. Typical leakage current waveform on the RTV SIR coated glass insulator in the case of intense activity, (a) Leakage current and voltage waveform (b) FFT spectrum of the leakage current and (c) Voltage current characteristic for the period with the highest value of leakage current within the activity of (a).
