# Assessment of Field Aged Composite Insulators Condition in Crete

**Abstract--** The performance of high voltage insulators utilized in overhead transmission and distribution lines is a key factor for the reliability of power systems. Surface hydrophobicity is a material oriented property and thus strongly correlated to the aging mechanisms experienced in service conditions. Although significant improvement has been achieved from the first generation of composite insulators to the third that is available today, there is still a need for evaluating the material condition so as to maintain the desired levels of reliability. For that purpose, field inspection techniques, such as IR and UV monitoring and leakage current have been implemented in service. Laboratory evaluation is also required aiming to obtain reliable information regarding the operational efficiency of a group of insulators that are in service. In the case of Crete, more than 50% of the installed insulators are composite using Silicone Rubber as housing material, with a service age from 2 to 20 years. During this period, no flashovers or other insulator faults have been recorded for the SIR insulators. However, their

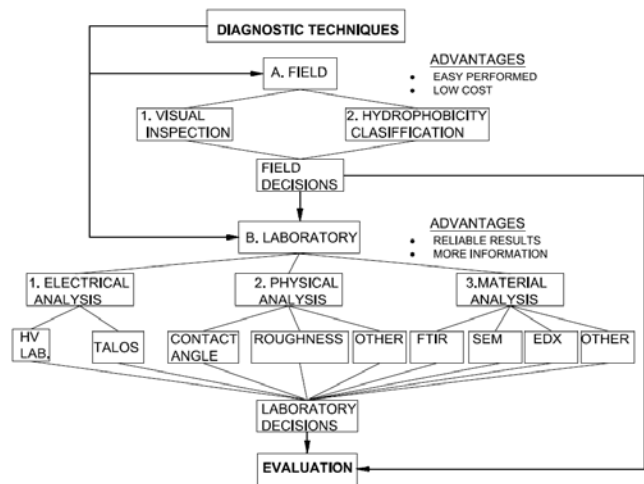
Fig. 1: A proposal evaluation procedure of field composite insulators

In this study an evaluation procedure is proposed, consisted of field and laboratory techniques, according to standards of international and national organizations (Fig.1). The aim is not only to detect the deteriorated insulator but also to provide more information for the field ageing mechanisms. Specifically, the field inspection is the first and the more definite stage of the evaluation aiming to detect degraded insulators. The results of the field techniques indicate the performed tests of the laboratory evaluation. Generally the laboratory evaluation procedure of the field insulators is performed after the field techniques, consisted of electrical, physical and material analysis techniques. Finally the combination of the laboratory inspection and the field inspection will determine the degradation level and the possible ageing mechanism.

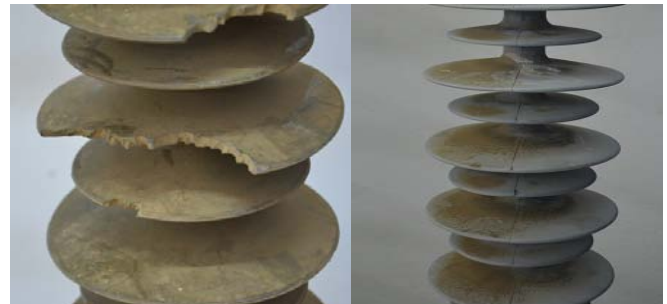
Fig. 2: Fault insulators in high voltage power system of Crete

Visual observation includes an intensive visual scanning of the structural parts of the field composite insulator, namely polymeric housing, corona rings, and metal fittings [23]. The usage of binoculars or telescope is desirable to get reliable results due to small size of the faults. Alternatively the visual observation could be performed by climbing on tower, using bucket truck or helicopter but the last methods are more expensive and time-consuming. Fig. 2 shows 2 degraded insulators the first caused by bird attack and the second by partial housing discoloration and intensive pollution.

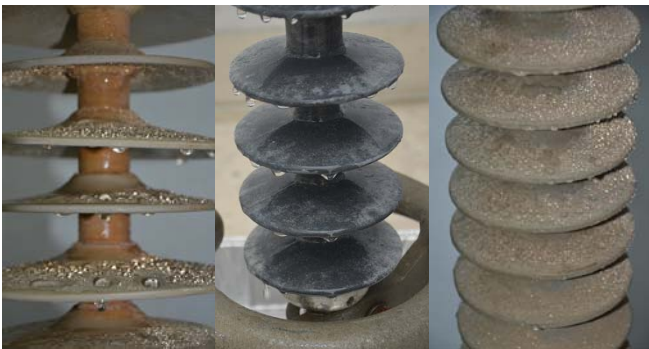
Hydrophobic class 1 Hydrophobic class 7 Hydrophobic class 1  
Fig. 4: Hydrophobicity classification of field composite insulators in high voltage network of Crete according to STRI [22]

The hydrophobicity classification; as an indicator of deterioration of composite insulators is performed in the field by applying the STRI Guide [22]. It is suggested to process this test after the mishandling of the composite insulators from the high voltage network but it can be also performed on the tower. The evaluation of the housing material hydrophobicity is based on a spray test method. The combination of the visual observation and the hydrophobicity classification could be an indicator for the performance of the outdoor high voltage insulator. The test is performed by using a common spray bottle, distilled water and a camera. The photographs of the wetting surfaces of the field insulators are compared with typical photographs of the STRI [22] guide for a quickly classification of the insulator surface. There are 7 typical hydrophobic categories according to guide [22]. Fig. 4 shows the differences between the hydrophobicity classification of the composite insulators installed in the high voltage network of Crete.

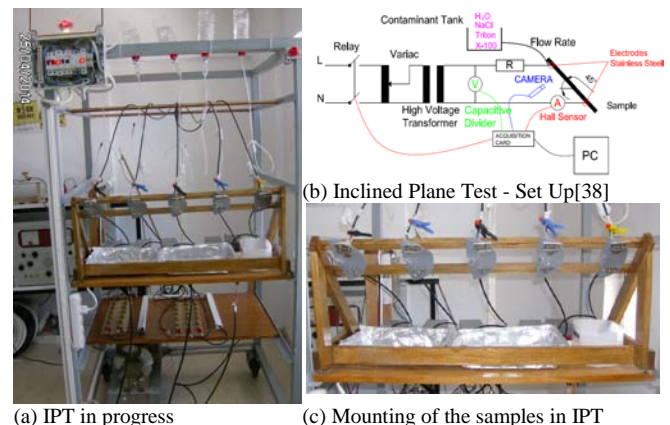
(a) IPT in progress (b) Inclined Plane Test - Set Up[38]  
Fig 5: Inclined Plane Test Details

The indoor high voltage tests are performed in appropriately equipped high voltage laboratories. Such setups are available at the high voltage laboratories of Technological Educational Institute of Crete and of Aristotle University of Thessaloniki. The performed tests include evaluation of housing material resistance against tracking and erosion according to IEC60587 (Fig. 5) [35]. In addition Dynamic Drop Test (DDT) [37] and corona test [37] are performed in order to evaluate the hydrophobicity efficiency of the polymeric housing against simultaneous stress by drops and voltage and against corona discharges respectively.

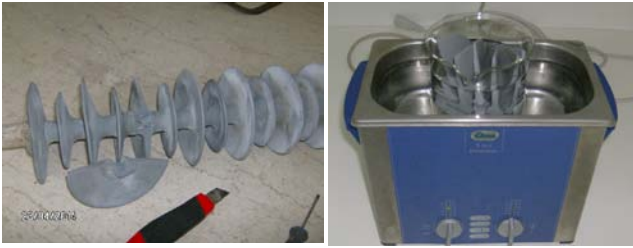
Sampling from a field high voltage composite insulator; 150 kV network of Crete

Fig. 6: Sampling and samples cleaning

In order to evaluate the polymeric housing of the composite insulator samples with specific dimensions are needed according to employed tests. Because this is impossible to perform in the commercial high voltage composite insulator a new sampling procedure is implemented (Fig. 6).

In order to be tested, samples need to be thoroughly cleaned in order to acquire reliable results. The samples are cleaned with distilled water before being extracted from the composite insulator housing (Fig. 6) and then an ultrasonic cleaner is employed in order to further remove the surface pollution of the samples. It must be noted that cleaning with chemical solutions is not acceptable because the polymeric housing is vulnerable to chemical solutions.

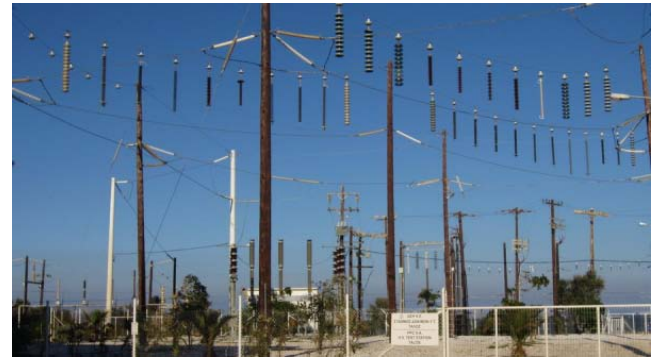
Fig. 8 : Suspension 150kV Insulators in Outdoor High Voltage Laboratory in Crete (TALOS)[39]

The outdoor high voltage tests are performed in coastal outdoor high voltage test station of Hellenic Electricity Distribution Network Operator in Crete (TALOS test station) [39] (Fig. 8). During the testing period the electrical activity of the insulator is recorded and breakdown voltages (Fig. 9) and leakage currents are measured. In addition to electrical measurements, meteorological data such as wind, temperature, UV radiation, pressure, humidity rainfall are recorded and pollution measurements are performed. In order to examine the performance of the field insulators there is the need of long exposure of the insulator in the outdoor laboratory under their nominal operation assessments.

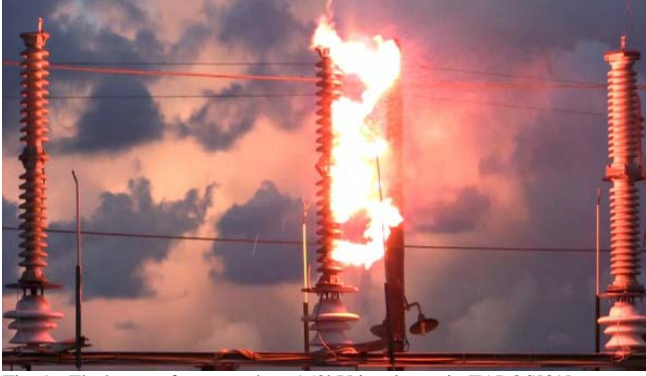
Fig. 9 : Flashover of post outdoor 150kV insulators in TALOS[39]

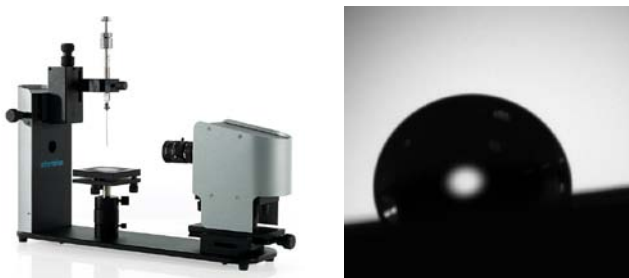
Fig. 10: Contact angle device (left) and measurement (right)

The physical measurements are performed in the Center of Materials Technology and Photonics of Technological Educational Institute of Crete. Until now there was the need to evaluate the hydrophobicity of the polymeric housing of composite insulators thus contact angle measurements are performed by using a contact angle device (Fig. 10).

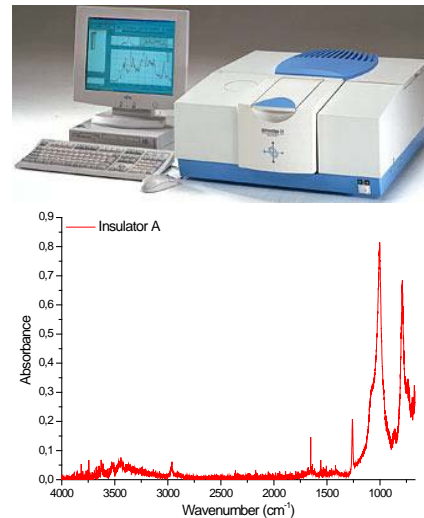
Fig. 11: FTIR spectrum of a SIR insulator of 150kV network of Crete

FTIR spectroscopy is used to detect the structural bonds of the housing material. In FTIR radiation which is produced from a source is passed through the sample. Some of the infrared radiation is absorbed by the sample and other transmitted. The operation of FTIR is based to the fact that each different material has a unique combination of atoms thus a unique absorbance in FTIR spectra. A FTIR spectrum provides information for the absence of a bond and simultaneously for the amount of the material present according to peak area integration of the specific bond. Fig. 11 shows a FTIR spectrum which represents the absorbance radiation of a silicon rubber with alumina fillers insulator.

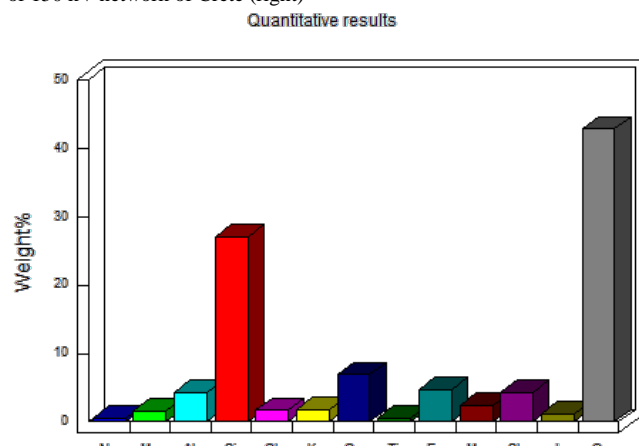
Fig. 13: EDX analysis of a field SIR insulator of 150kV network of Crete

Energy Dispersive X-Ray (EDX) is used to detect the elemental composition of the materials. The analysis (Fig. 13) could obtain information for the elemental composition

changes of the composite insulator housing material caused by the field aging mechanisms.
