Comparative Investigation of Silicone Rubber Composite and RTV Coated Glass Insulators Installed in Coastal Overhead Transmission Lines

Key words: glass insulators, RTV coated, leakage current, silicone rubber, composite insulators, transmission lines, substations

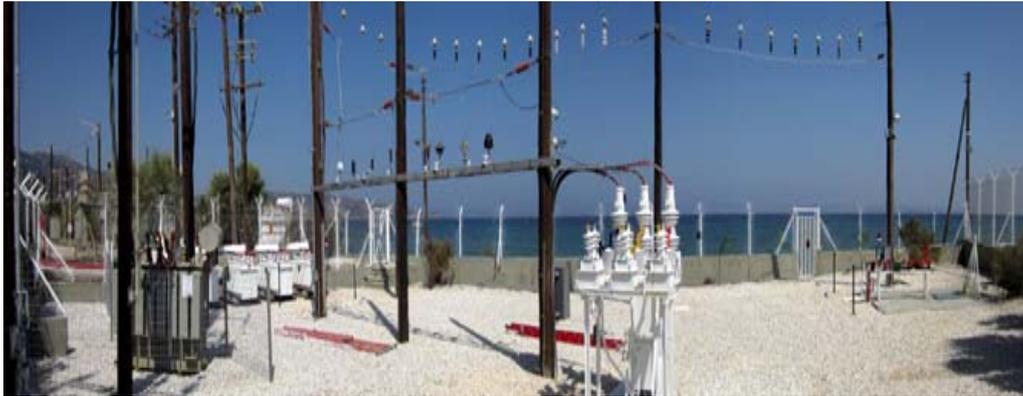
Figure 2. Photograph of the TALOS insulator test station in Iraklion Crete (21 kV bay)

The simultaneous installation of coated glass strings and composite insulators at the same towers, underlined the need of further research on the comparative performance of such insulators. HEDNO operates an open air high voltage test station (TALOS) in Iraklion, Crete. The TALOS test station (Figure 2) is located right next to the coast within the Linoperamata Substation. Initially, only of bay was installed for testing 150 kV post and suspension insulators but the station was upgraded in 2011 and now has three bays for testing of 21 kV and 150 kV post and suspension insulators [23], [25]. During the first stage of operation, one RTV coated glass string and one HTV SIR composite insulator was installed in the test station and monitored from July to October in which prior research has shown that surface activity meets its peak during this period and that the vast majority of pollution related outages has been recorded during these months. The monitored insulators had similar characteristics with those installed in the towers of the Atherinolakos-Ierapetra line and their basic characteristics are outlined in Table 2.

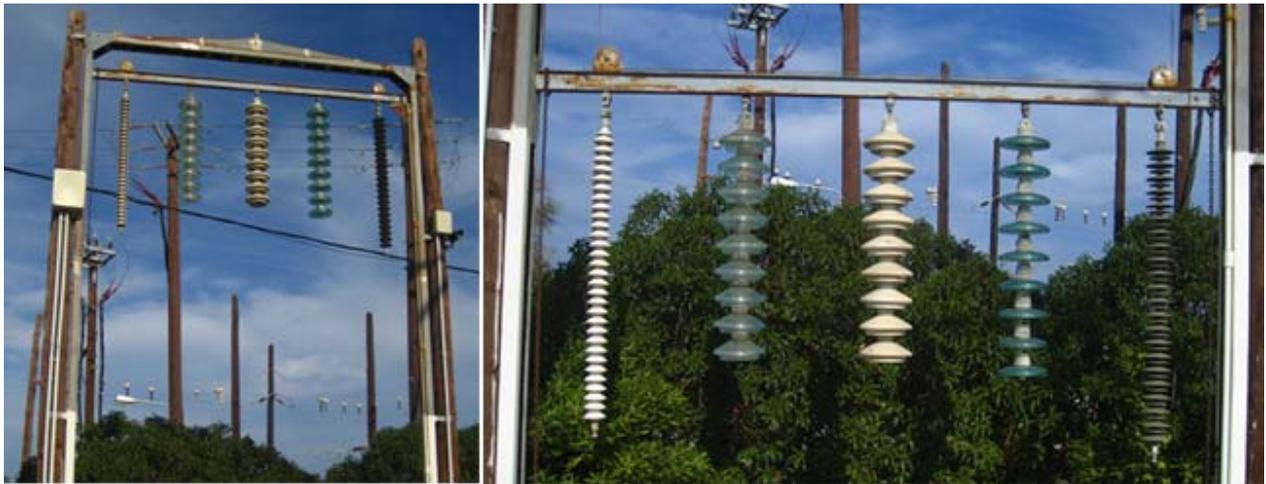
Figure 5. The ESDD-NSDD arch in TALOS.

TALOS is equipped with a structure (arch) that is used for hanging insulators to compare insulator contamination in terms of equivalent salt deposit density (ESDD) and non-soluble deposit density (NSDD) levels [25], [29]. Photographs of the structure are shown in Figure 5.

The latest pollution measurement test series initiated in June 2014 included a factory precoated glass insulator, on which the coating was very uniform, that was installed in the arch, in the place of the far-left insulator shown in Figure 5. This insulator string was hanged before for over one year at TALOS accumulating significant amount of pollutants, especially sand. After its installation on the arch, all insulators were washed with low pressure water with a hose in order to initiate a new set of measurements. During this washing it became evident that all insulators were easily cleaned with the exception of the pre-coated one as sand could not be fully removed, and in fact using a sponge became necessary to remove the sand from the surface. Therefore, the increased NSDD measurement seems to be more related to the nature of the surface of the RTV coating and not as much to the coating procedure.
